# Accessibility Guidelines for tourism destination

**QUAD: Accessible Eco-Tourism Social Entrepreneurship  
(HUSRB/1602/42/0045)**

Increased understanding and knowledge on accessibility in tourism  
**Act.1.3 Accessibility Guidelines for tourism destination**

*Created by Motiváló Limited Partnership (42 Tegzes street, Budapest)  
Lead Expert: Péterné Zalabai, rehabilitation environmental expert  
Commissioned by the Association of Persons with Disabilities, Csongrád county*

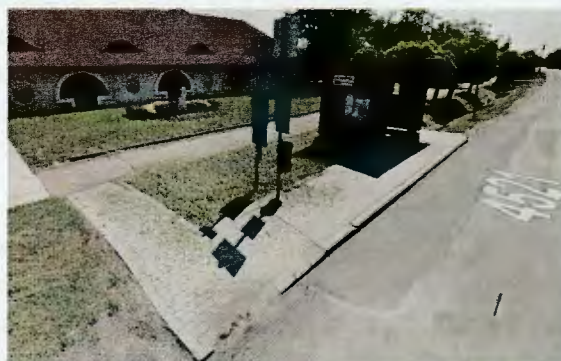
Name of Institution: **Bus Stops**

**General findings around accessibility:** There are four bus stops within the village, two in each direction. Two of them are renovated, and the platform is connected to the high-quality bike path with a ramp. Visitors need to inquire in advance at the regional bus transportation company (DAKK) to understand whether low-floor buses are running along these routes.

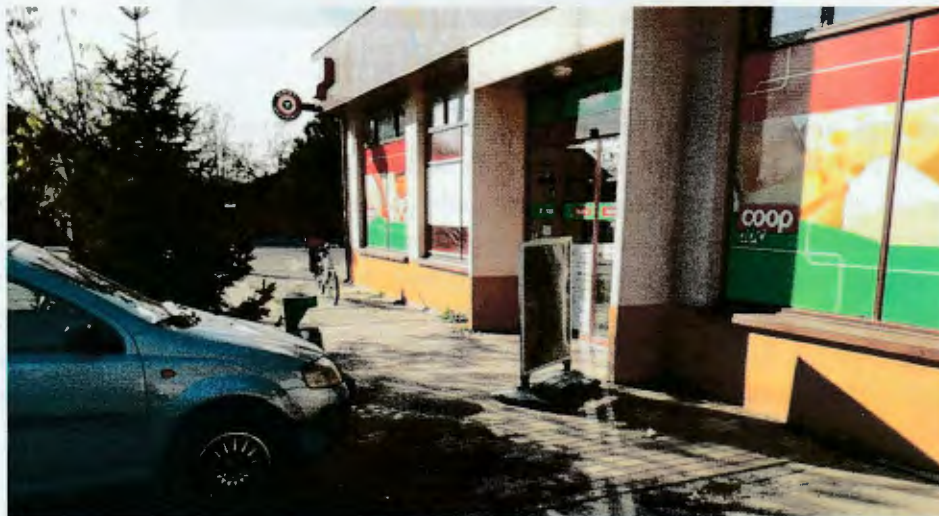
**General findings around accessibility:** The main grocery store is located in the centre of the village. There is an accessible parking space across the street. The shop can be reached without a level difference through a sliding door with photocell sensors. The clearance between the shelves does not allow for free movement with a wheelchair, and it is made even harder by the temporary promotional product stands, which narrow down the available space even more. There is only one entrance and one exit, which creates a forced route for the customers.

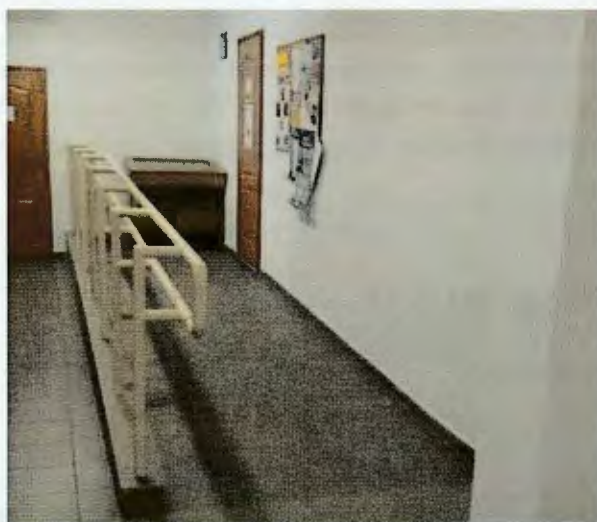
**General findings around accessibility:** There is an accessible parking space not far from the village centre. Visitors need to get around the building itself to arrive to the entrance. A ramp, which complies with the relevant regulations, leads to the front door. Most of the floors in the building have a non-slip surface, except for the conference room, where there are polished parquet floors. The size of the doors is acceptable everywhere. In the accessible bathroom, the toilet is located in the corner, so it can only be approached from the front and from the left. The height of the washbasin is 90 cm, but it can be tilted. The bathroom is also equipped with a changing table. The municipal library is also located in the building; its entrance is accessible by a ramp.

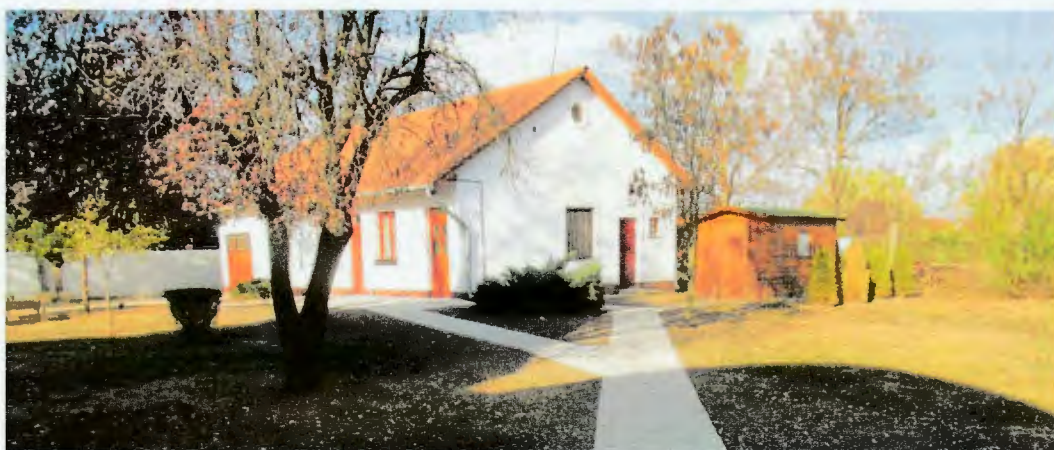
**General findings around accessibility:** The future pharmacy is currently under construction in a separate building in the courtyard of the village centre. As the doctor's office can also be found in the village centre, this location is very convenient. However, arriving from the street is made difficult by the pavement's fragmented surface. Luckily, the path that leads to the pharmacy building itself is freshly constructed with a smooth surface. There is no accessible parking in the close proximity of the building. A new field visit is recommended after the construction is complete and the pharmacy opens.

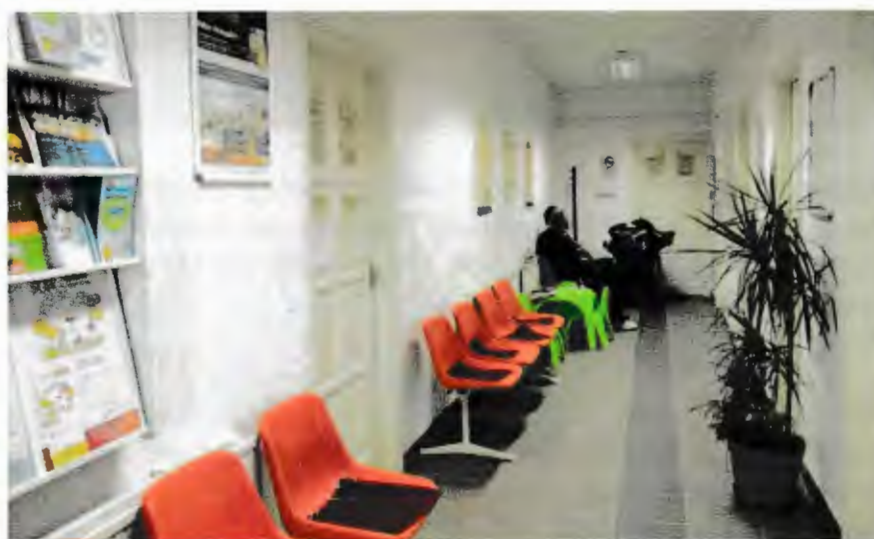
**General findings around accessibility:** The doctor's office is located in the same building as the village centre. At the front door, a mini wooden ramp was put in place to bridge the level difference of the threshold. Inside the building, visitors need to make two left turns to get to the waiting room. There are direction signs in place, and their size and font meet the expectations. Along the corridor leading to the doctor's offices, chairs have been put in place for the patients waiting. Potted plants have been also placed in several spots on the opposite wall, which can obstruct the movement of people with visual disabilities. One line of the tiles was laid in a different colour, but its surface is the same as the other tiles, and its colour is not contrasting enough to function as tactile paving. The accessible bathroom is spacious; the toilet is located in the corner, so it can be approached from the front and from the right. The washbasin can be tilted and has appropriate knee clearance.

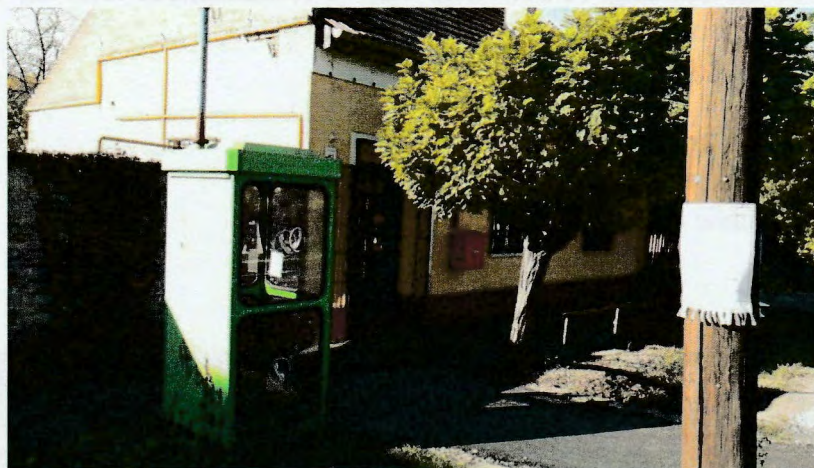
**General findings around accessibility:** There is no accessible entrance to the post office, as the only door is too narrow and has a high threshold. The space inside the building is tight, and the customer service window is situated quite high. The post office is the only place in the village where people can withdraw money.

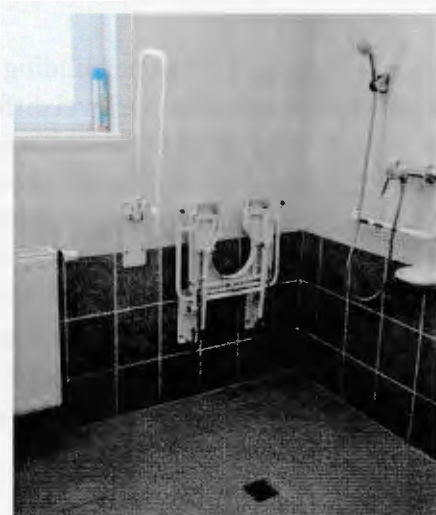
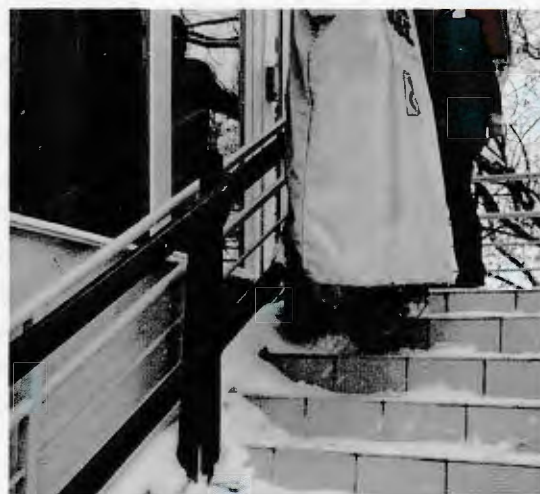
**General findings around accessibility:** As it is located in the recreation area, in the floodplain, the building has no public transport connections; it can only be reached by car. Parking is possible in the yard, right next to the entrance. The front door can be accessed by a staff-operated stair lift. The front door complies with the relevant regulations. In the interior, there is even and non-slip flooring everywhere. The upstairs area is currently not accessible. The accessible bathroom is in compliance with the regulations: the toilet can be accessed from the front and from the left. In the shower, the drain is in line with the floor it is equipped with a seat. On the ground floor, there is an accessible room suitable for 3 people, where the space between the beds is a little tight.

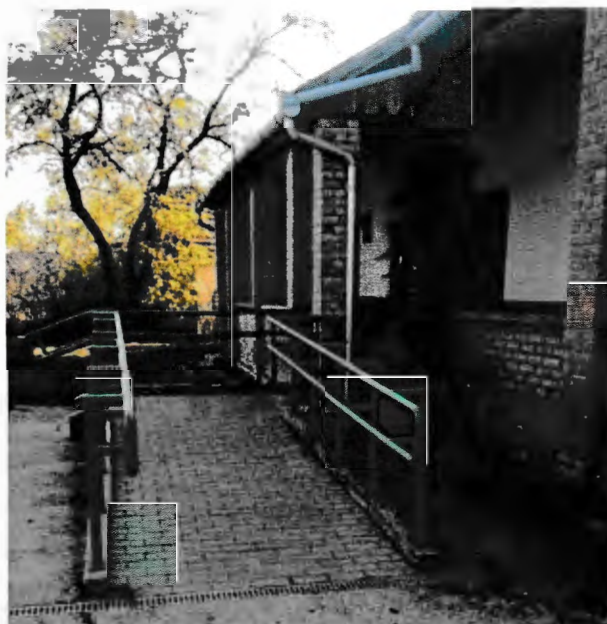
**General findings around accessibility:** The pavement leading up to the entrance is quite fragmented, which makes the pedestrian access a bit inconvenient. There is no accessible parking next to the entrance, but there is enough free space for comfortably getting in and out of the car. A ramp, which complies with the regulations, leads to the front door. There is even and non-slip flooring everywhere inside the building. The size of the doors allows for wheelchair access everywhere. In the accessible bathroom, the toilet can only be accessed from one direction, and turning around with a wheelchair might prove difficult due to lack of space. The shower design complies with the regulations and it even has a separate alarm system. The rooms have bunk beds; the lower beds meet the requirements in a total of three rooms.

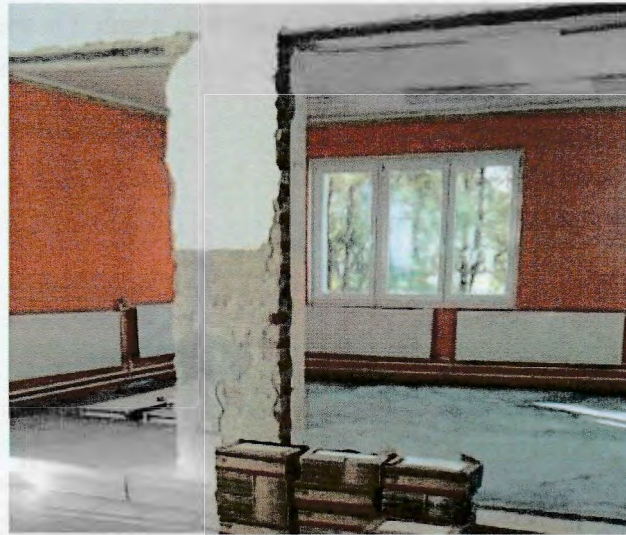
**General findings around accessibility:** The kitchen is located in the Village Centre building and is currently under renovation. According to the design plans, the new establishment will be fully accessible. A new field visit is recommended after the construction is complete and the kitchen opens.

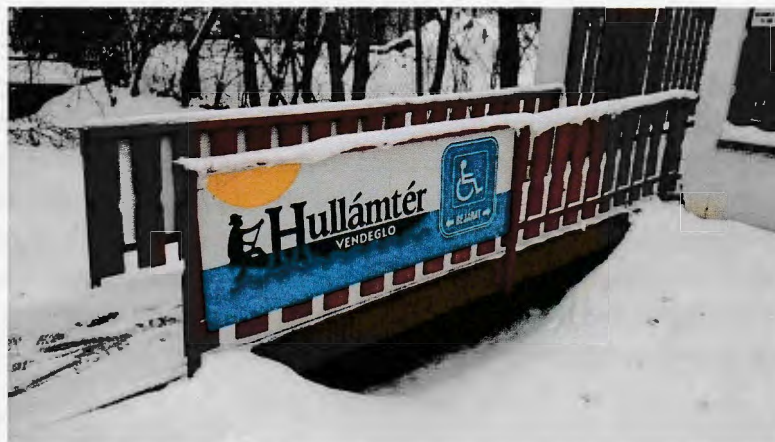
Name of Institution: **Hullámtér Restaurant**

**General findings around accessibility:** As it is located in the recreation area, in the floodplain, the building has no public transport connections; it can only be reached by car. There is no accessible parking due to lack of space. The building is easily accessible from the main road; the level difference is bridged by a ramp, which complies with the regulations. The front door currently has a 5 cm high threshold, which the owner plans to remove. There is even and non-slip flooring everywhere inside the building. The tables have appropriate knee clearance, and although they are quite close to each other, the room can be easily rearranged. There are currently no accessible bathrooms.

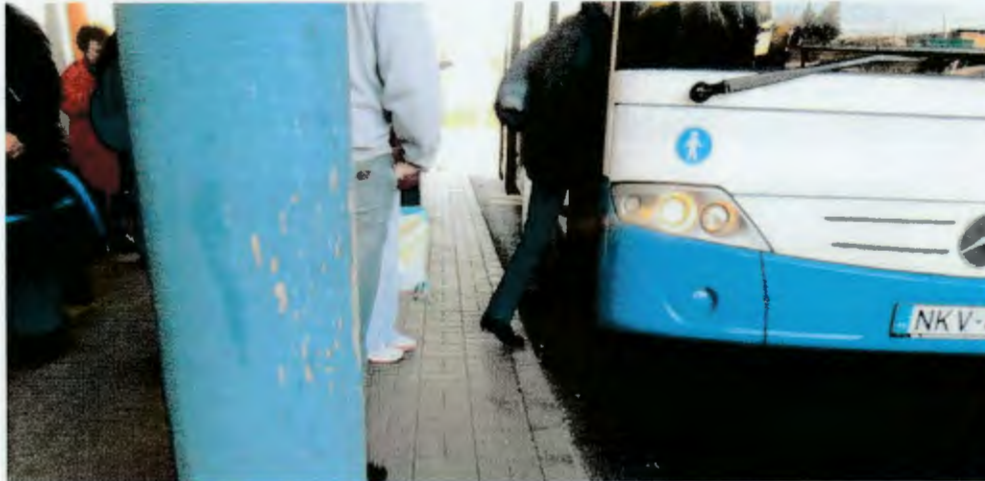
**General findings around accessibility:** There is even and non-slip flooring everywhere in the station. The platform edges are not rounded everywhere. The entrance to the station building is accessible without level difference.

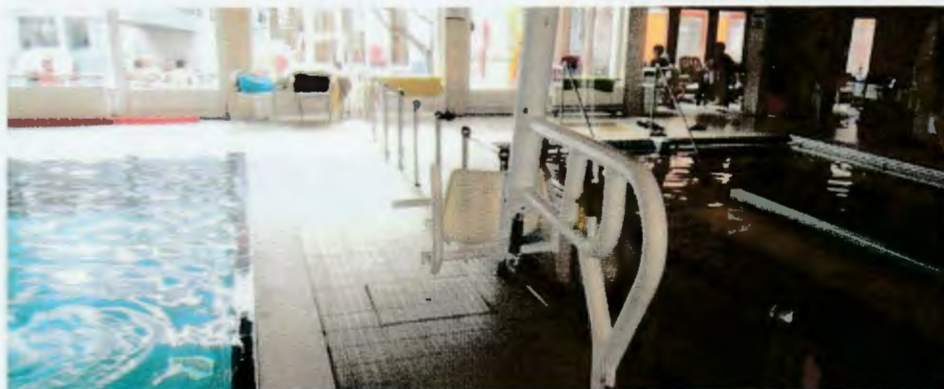
**General findings around accessibility:** There are accessible parking spaces right next to the building. At the entrance, the level difference is bridged with a ramp that complies with regulations. Information boards support orientation in the building. An information leaflet written in Braille is available at the reception desk. There are accessible bathrooms at three different

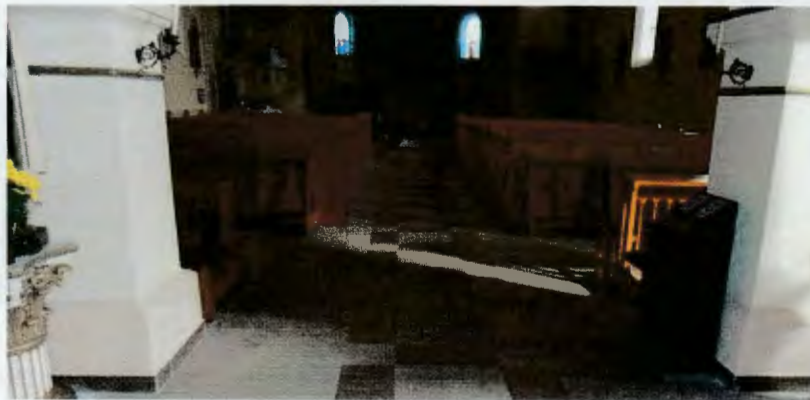
**General findings around accessibility:** The entrance to the church is accessible without level difference. The door is really heavy as it belongs to a historical building, and the door handle is situated quite high, so people using a wheelchair might need help opening it. There is even and non-slip flooring inside the building and there is ample natural light. There are no accessible bathrooms.

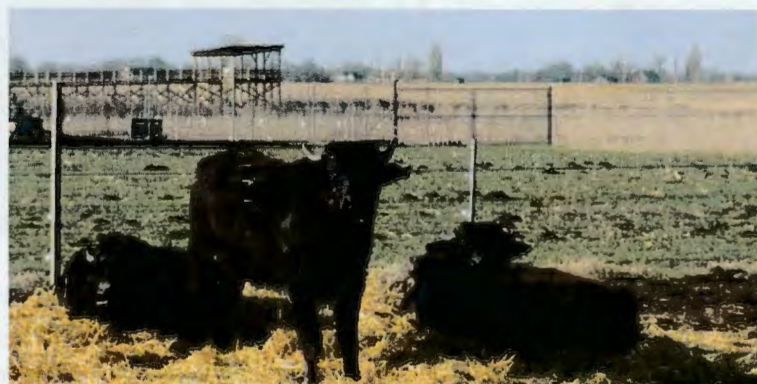
**General findings around accessibility:** The ramp leading up to the lookout point starts from the parking lot next to the road. The views include the area of Lake Nagyszéksós and the living habitat of the buffalo.

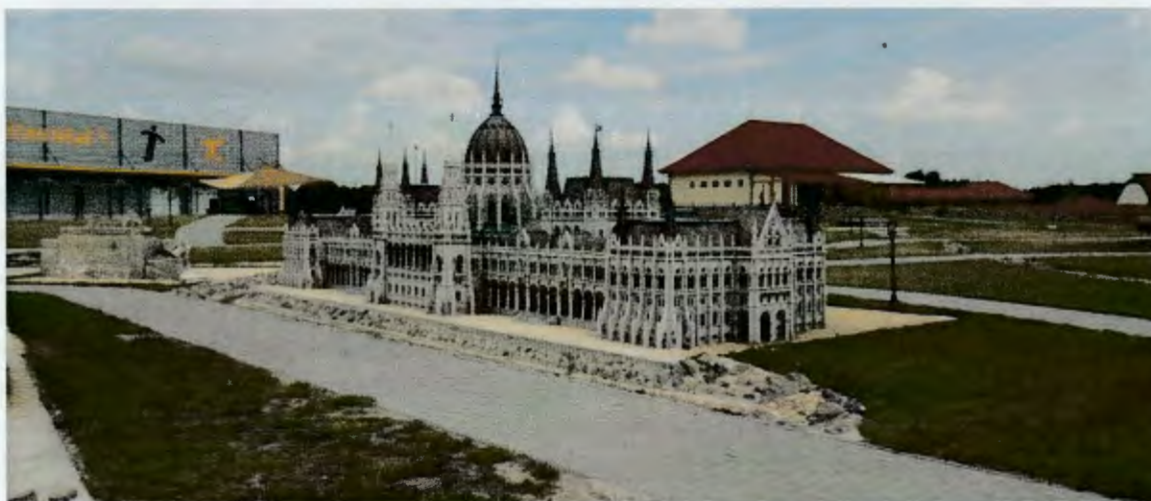
**General findings around accessibility:** As the park is located outside of Mórahalom, it has no public transport connections; it can only be reached by car. There is accessible parking right next to the entrance. At the front door, the level difference is bridged by a ramp that complies with regulations. There is a smooth pathway between the different miniature buildings. Audio guides are available. The conference room is also easily accessible. In the accessible bathroom, the toilet can be approached from the front and from the left and it has a handrail. The height of the washbasin is acceptable and it is equipped with a handrail.

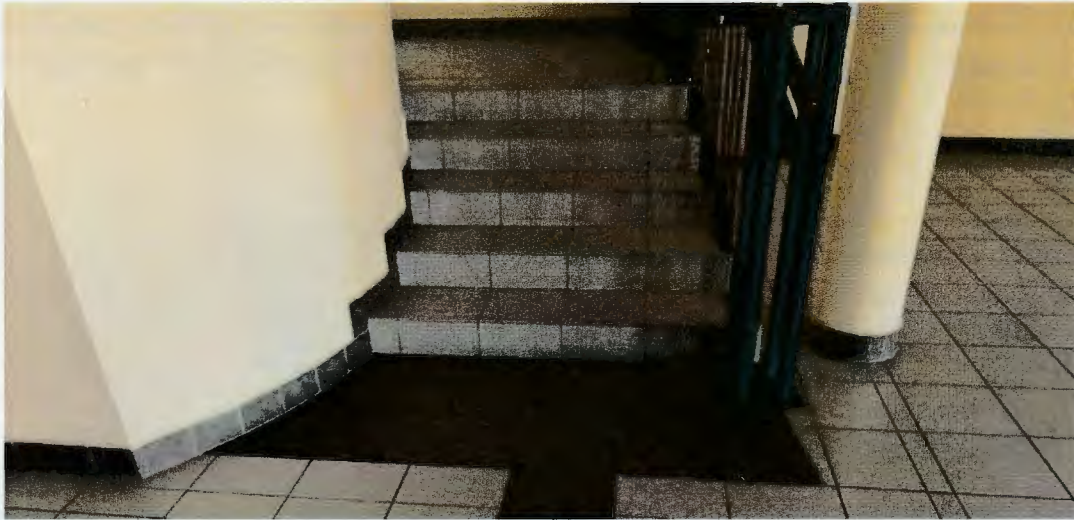
**General findings around accessibility:** There is accessible parking next to the building. At the front door, the level difference is bridged by a ramp that complies with regulations. There is also tactile paving leading from the parking lot to the ramp. The entrance door of the building meets the relevant requirements. In the interior of the building, contrasting coloured floor tiles help people with visual disabilities. There is even and non-slip flooring everywhere inside the building. Movement between floors is made accessible by an elevator, which complies with regulations. In the stairway, the different coloured floor tiles mark the start and the end of the stairs, and there is a handrail along the whole length of the staircase. There are information signs to help orient visitors. In the accessible bathroom, the toilet can be approached from the front and from the left. The washbasin is at the right height and has appropriate knee clearance.

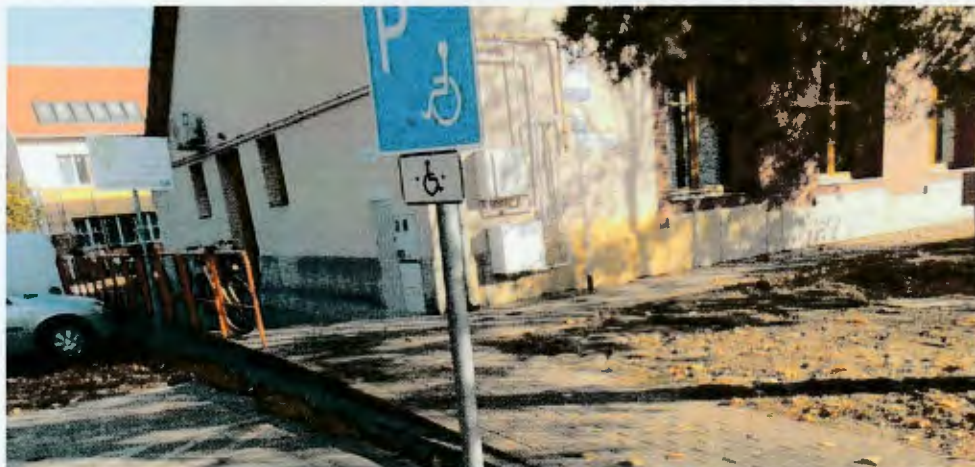
**General findings around accessibility:** There is accessible parking right next to the entrance. At the front door, the level difference is bridged with a ramp that complies with regulations. Inside the building, the flooring is even and non-slip. The client window is fully accessible. An induction loop was installed for the people with hearing disability and an information leaflet written in Braille is available for the people with visual disability.

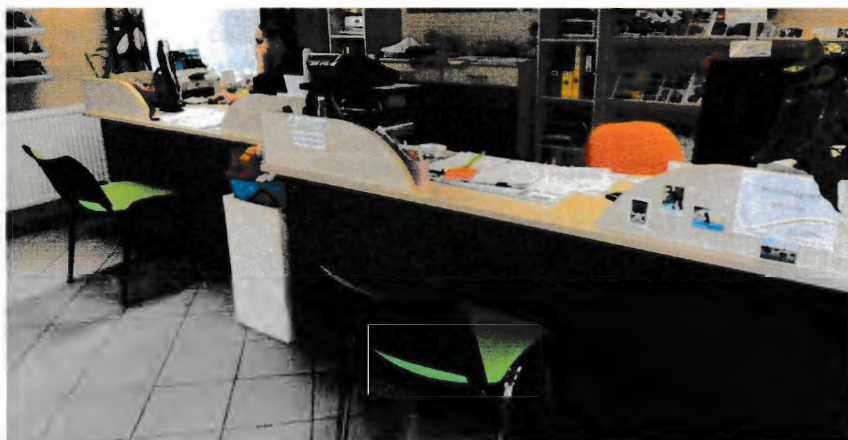
**General findings around accessibility:** There is accessible parking next to the building. At the front door, the level difference is bridged by a ramp. The entrance door of the building meets the relevant requirements. There is even and non-slip flooring inside the building. The height of the client desk is appropriate; however, it does not have appropriate knee clearance.

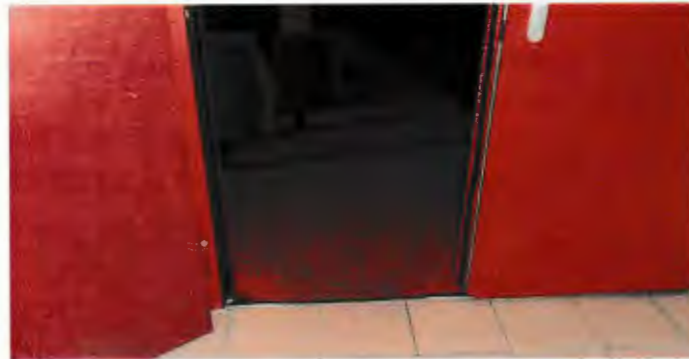
**General findings around accessibility:** There is accessible parking next to the building. The front door is accessible without a level difference, and the door meets the relevant requirements. There is even and non-slip flooring inside the building. The cloakroom, the snack bar and the ticket office are also accessible. The theatre room has designated places for wheelchairs right next to the entrance, which does not affect the evacuation route. The accessible bathroom meets the requirements: the toilet can be approached from the front and from the left; the washbasin is at the right height and has appropriate knee clearance.

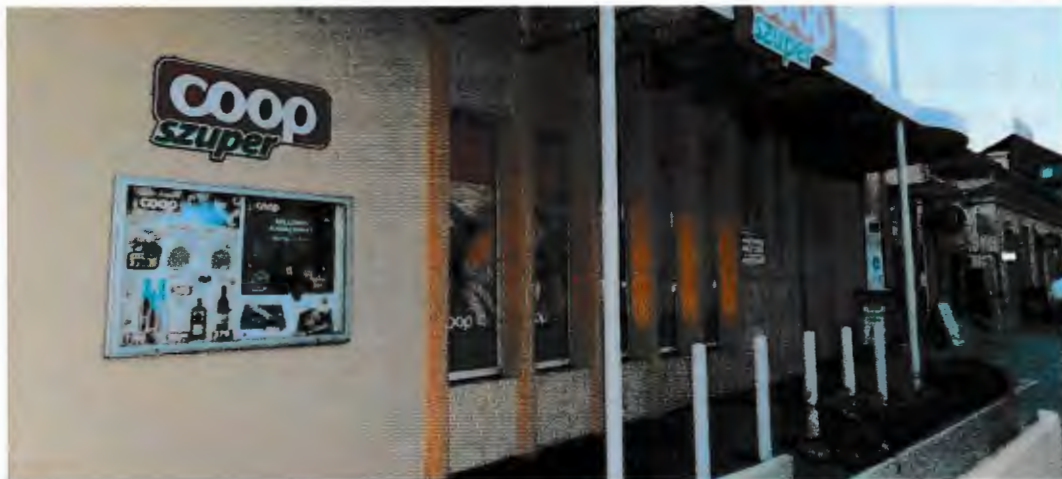
**General findings around accessibility:** There is accessible parking next to the building. At the front door, the level difference is bridged by a ramp that complies with regulations. There are big information boards, which help customers to get familiar with the prices. There is also an accessible ATM next to the entrance of the store. Inside the store, the clearance between the shelves is suitable for wheelchair users, and cashier number one is wide enough so that people using wheelchairs can pay comfortably.

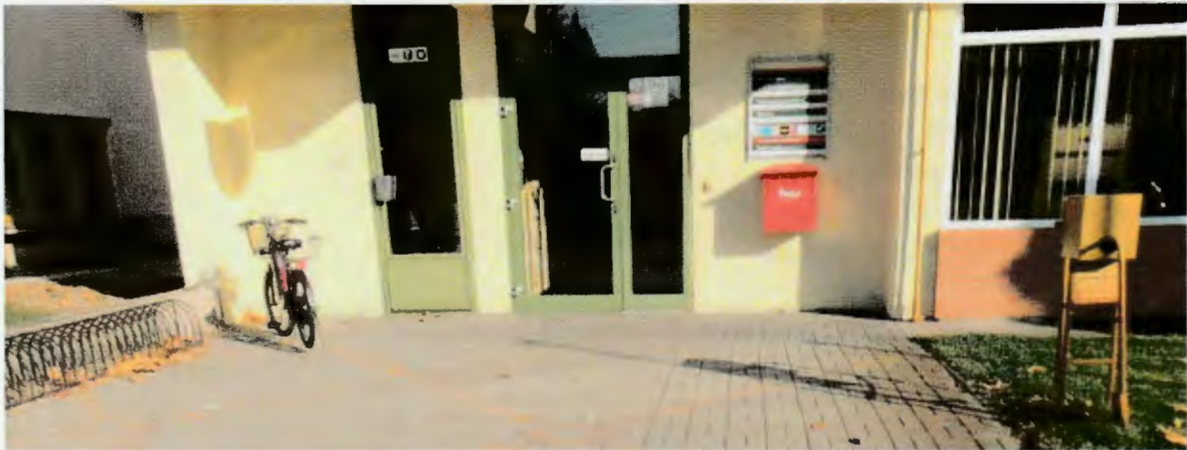
**General findings around accessibility:** There is accessible parking next to the building. The front door is accessible without a level difference. There is even and non-slip flooring inside the building. The information boards are easy to read. The height of the client desk is appropriate; however, it does not have appropriate knee clearance. There are no accessible bathrooms.

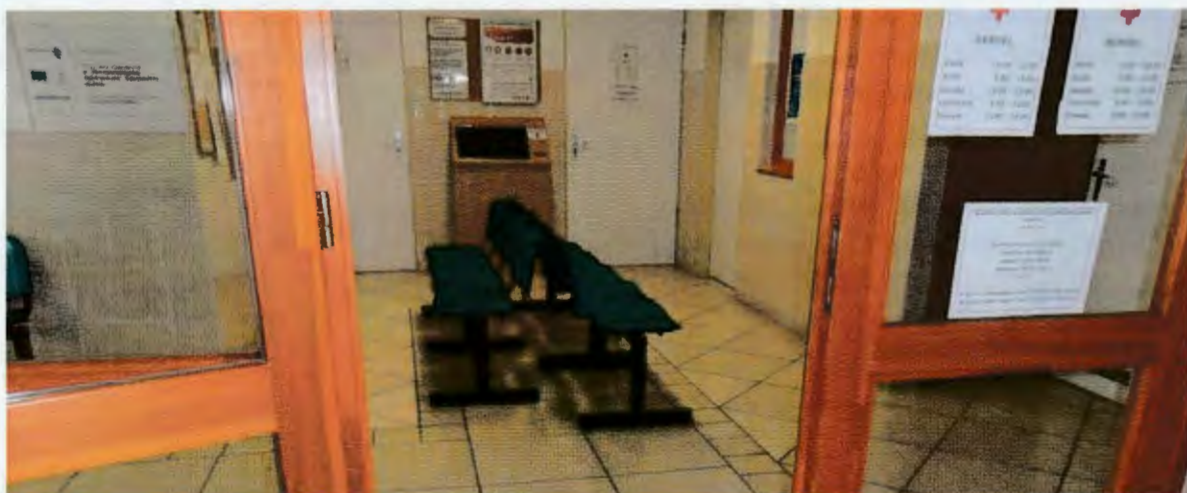
**General findings around accessibility:** There is accessible parking next to the building. At the front door, the level difference is bridged by a ramp that complies with regulations. There is even and non-slip flooring inside the building. The information boards are easy to read and understand. In the waiting room, there is enough clearance to move around in a wheelchair. In the examination room, the equipment also allows for free movement. In the accessible bathroom, the toilet can be heightened with an additional seat. The toilet is accessible from the front and from the left. The washbasin is at the right height and has appropriate knee clearance.

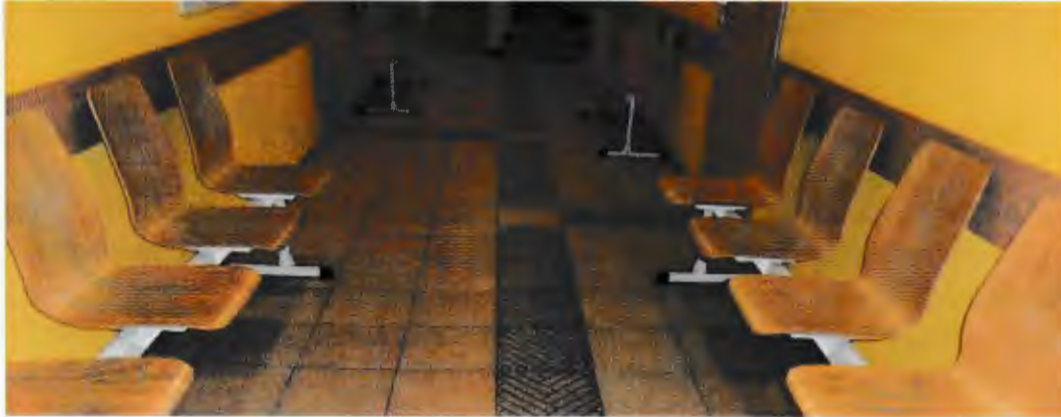
**General findings around accessibility:** There is accessible parking next to the building. At the front door, the level difference is bridged by a ramp that complies with regulations. There are information signs to help visitors with orientation. There is even and non-slip flooring inside the building. Tactile paving leads to the examination rooms. Movement between floors is made accessible by an elevator, which complies with regulations. The staircase and the steps also comply with regulations. The accessible bathroom meets the requirements: the toilet can be approached from the front and from the left. The washbasin is at the right height and has appropriate knee clearance, the mirror can be tilted.

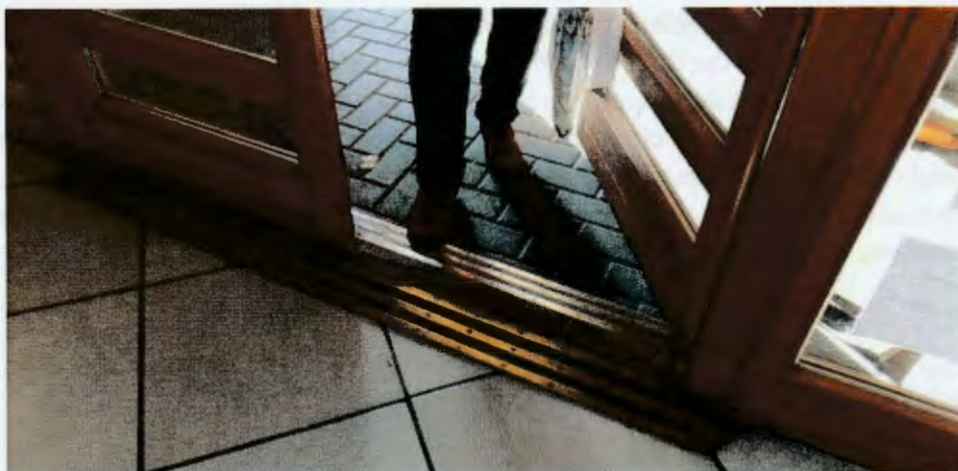
**General findings around accessibility:** The pharmacy is located in the same building as the health centre. There is accessible parking next to the building. At the front door, the level difference is bridged by a ramp that complies with regulations. The threshold at the front door is bridged by a metal mini ramp. There is even and non-slip flooring inside the building, with no thresholds at any of the interior doors. The height of the client window is not appropriate and it does not have appropriate knee clearance. In the accessible bathroom, the toilet can be heightened with an additional seat. The toilet is accessible from the front and from the left. The washbasin is at the right height and has appropriate knee clearance.

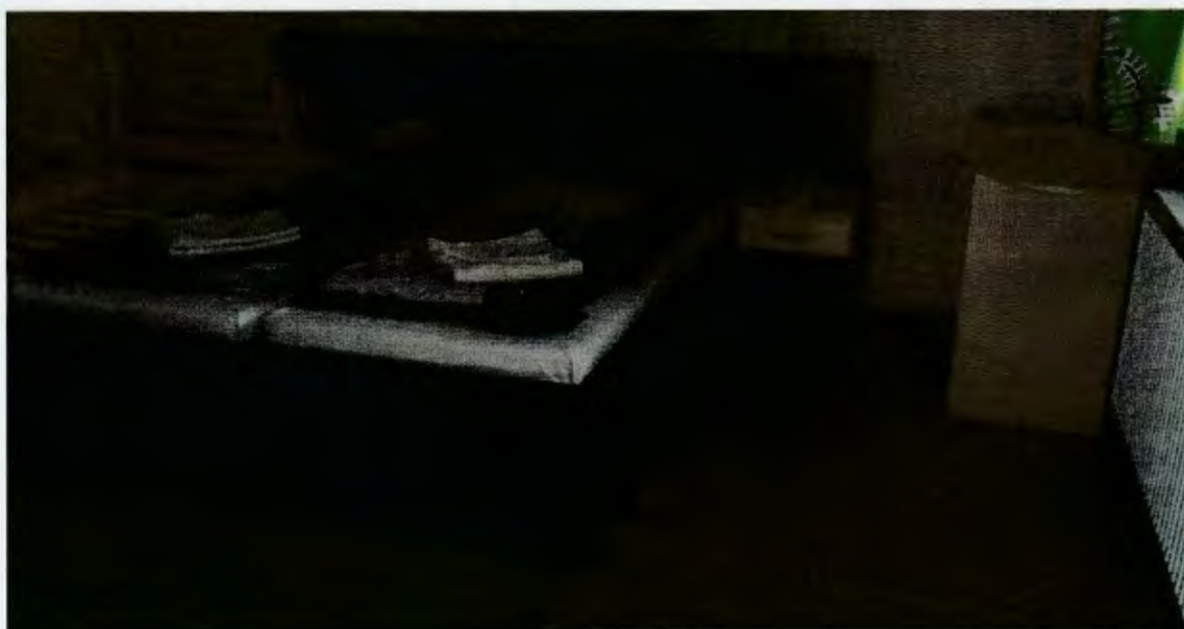
**General findings around accessibility:** Accessible parking is available nearby in the parking lot of the Tourinform Office. At the front door, the level difference is bridged by a ramp that complies with regulations. In the accessible room, the height of the bed is appropriate for transferring from a wheelchair, and there is enough clearance between furniture pieces to move around easily. The accessible bathroom meets the requirements: the toilet can be approached from the front and from the left. The washbasin is at the right height and has appropriate knee clearance, the mirror can be tilted. The shower has no thresholds and the drain is in line with the floor.

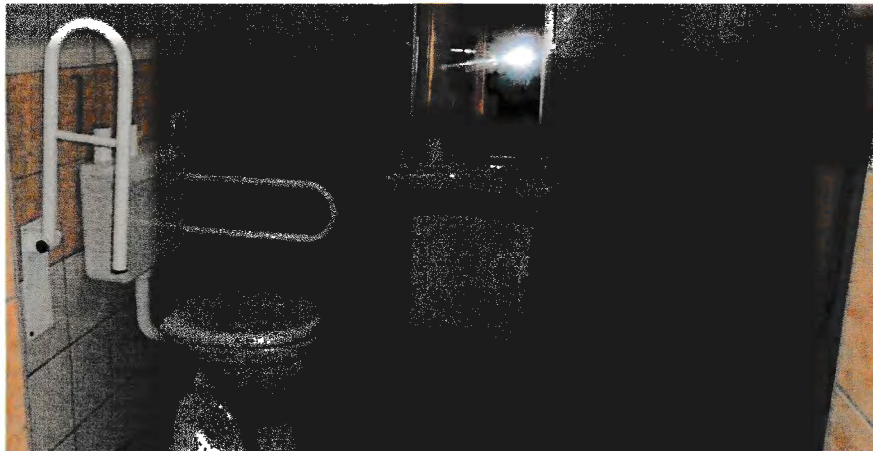
**General findings around accessibility:** The property has one accessible parking space for guests with disabilities. At the front door, the level difference is bridged by a ramp that complies with regulations. Tiles laid in contrasting colours help the orientation of guests with visual disabilities. The accommodation has one accessible room where enough space can be provided if the extra bed is removed. The accessible bathroom meets the requirements: the toilet has the ideal placement as it can be approached from the front and from both sides. The washbasin can be tilted, but the handle obstructs the appropriate knee clearance. The shower has no threshold and the drain is in line with the floor.

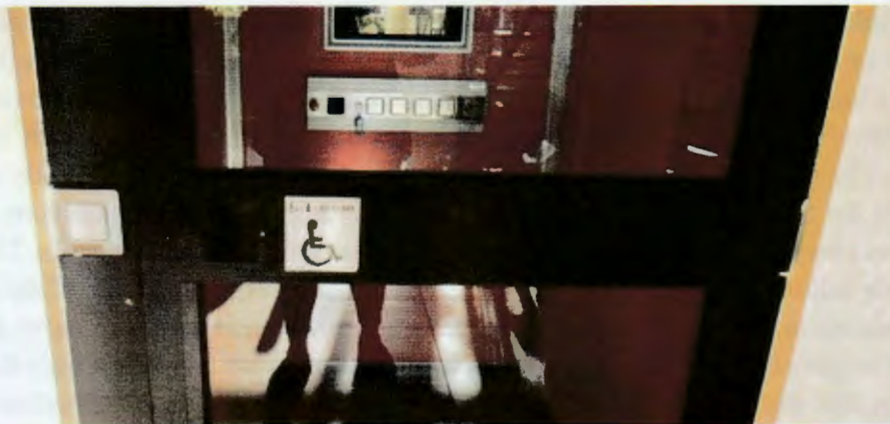
**General findings around accessibility:** The accommodation can host 5 people with disabilities at the same time. The building can only be approached by car, as it is 8 kilometres from the city centre. At the front door, the level difference is bridged by a ramp that complies with regulations. The reception desk has an accessible section. Movement between floors is made accessible by an elevator, which complies with regulations. The staircase and the steps also comply with regulations. In the accessible bathroom, the toilet is equipped with handrails, but it sits too low. The shower has no thresholds and the drain is in line with the floor. In the accessible room, there is enough free space between furniture pieces to move around easily. The conference room is also accessible.

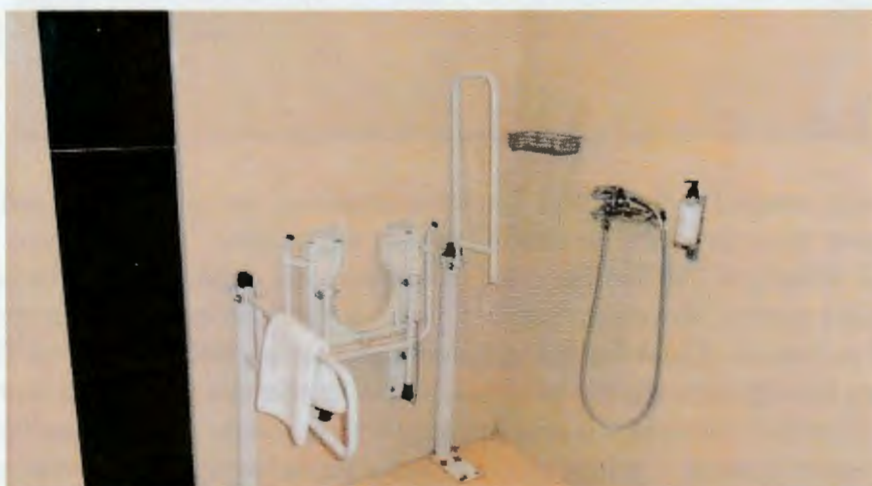
**General findings around accessibility:** The accommodation can host 4 people with disabilities at the same time. There is designated parking next to the building. At the front door, the level difference is bridged by a ramp that complies with regulations. There is an induction loop at the reception. Movement between floors is made accessible by an elevator, which complies with regulations. The staircase and the steps also comply with regulations. Differently coloured tiles marks where the floor meets the walls on the corridors. In the accessible bathroom, the toilet can be approached from the front and from the right and it is equipped with handrails. The shower has no thresholds and the drain is in line with the floor. It is also equipped with a fold-down seat. In the accessible room, there is enough free space between furniture pieces to move around easily. The correct height of the bed is ensured by an additional mattress. There is a high threshold at the balcony door, this the only part of the room that is not accessible. At the hotel restaurant, the tables have appropriate knee clearance, and there is enough clearance between them. The height of the buffet table is appropriate but it does not have appropriate knee clearance.

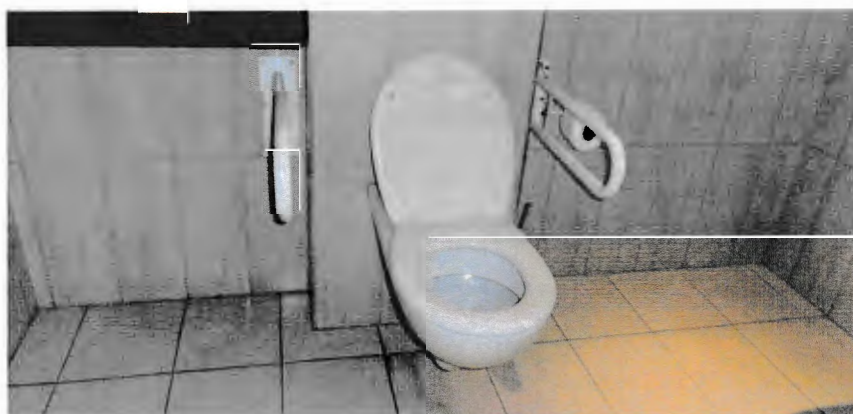
**General findings around accessibility:** The accommodation can host 4 people with disabilities at the same time. There is accessible parking next to the building. The front door is accessible without a level difference. The flooring in the reception area is quite slippery. The reception desk has an accessible section. Movement between floors is made accessible by an elevator, which complies with regulations. The staircase and the steps also comply with regulations. The accessible bathroom meets the requirements: the toilet has the ideal placement as it can be approached from the front and from both sides and it is also equipped with handrails. In the accessible room, there is enough free space between furniture pieces to move around easily. At the hotel restaurant, the tables have appropriate knee clearance. The height of the buffet table is appropriate but it does not have appropriate knee clearance.

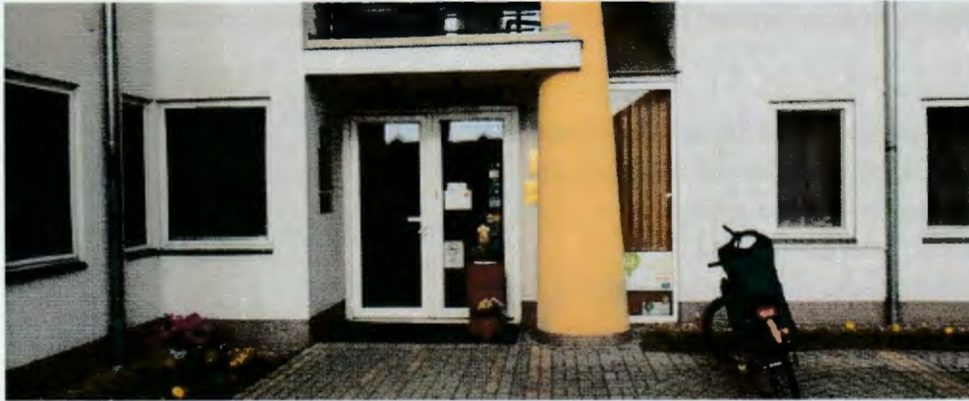
**General findings around accessibility:** The accommodation can host 2 people with disabilities at the same time. There is accessible parking next to the building. The front door is accessible without a level difference. The reception desk has an accessible section. The accessible room is located on the ground floor and its doors have the right dimensions. In the accessible room, the height of the bed is appropriate for transferring from a wheelchair. In the accessible bathroom, the toilet is equipped with handrails, but it sits too low. The shower has thresholds so it is not accessible.

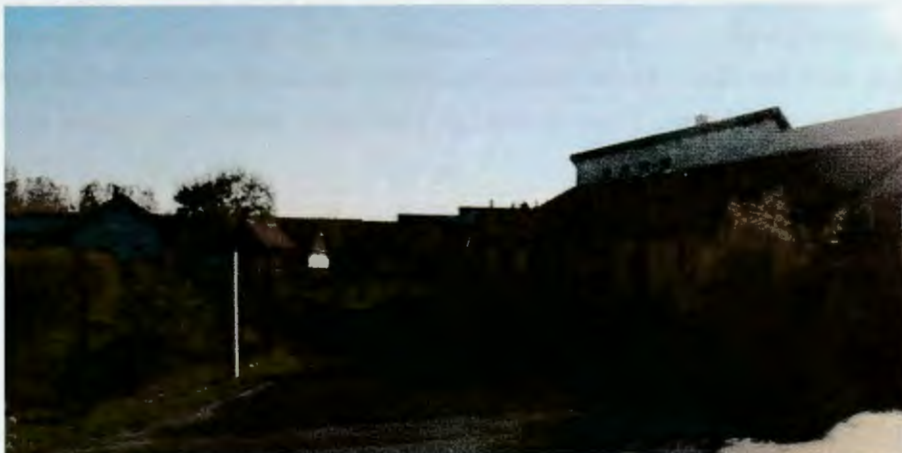
**General findings around accessibility:** The accommodation can host 2 people with disabilities at the same time. There is no designated parking. The front door is accessible without a level difference. There is even and non-slip flooring inside the building. In the accessible bathroom, the toilet is equipped with handrails, but it sits too low. The shower has no thresholds and the drain is in line with the floor. It is also equipped with a fold-down seat. In the accessible room, the correct height of the bed is ensured by an additional mattress, and there is enough free space between furniture pieces to move around easily. The conference room is also accessible.

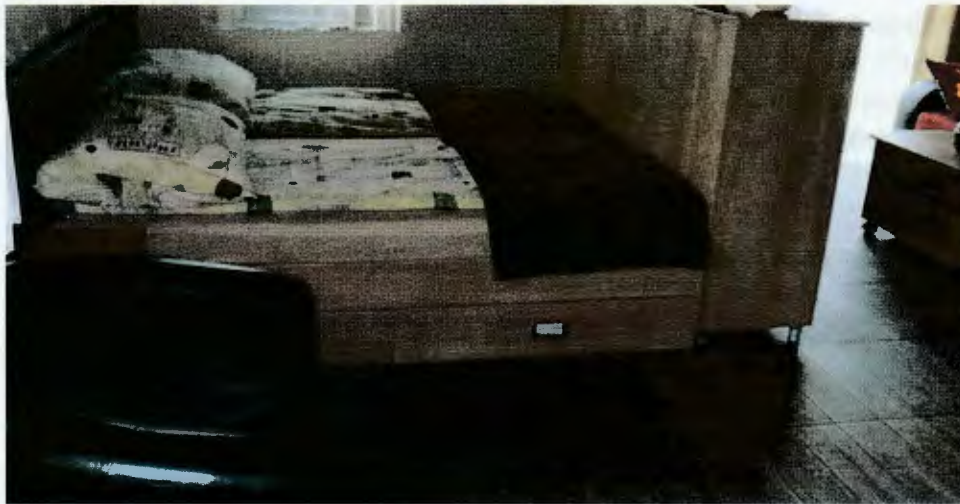
**General findings around accessibility:** The accommodation can host 2 people with disabilities at the same time. There is no designated parking. At the front door, the level difference is bridged with a ramp that complies with regulations. The accessible room is located on the ground floor and its doors have the right dimensions. In the accessible room, the height of the bed is appropriate for transferring from a wheelchair. There is enough free space for people in wheelchairs only on one side of the bed. In the accessible bathroom, the toilet is equipped with handrails, but it sits too low. The shower has no thresholds, the drain is in line with the floor and it has a fold-down seat.

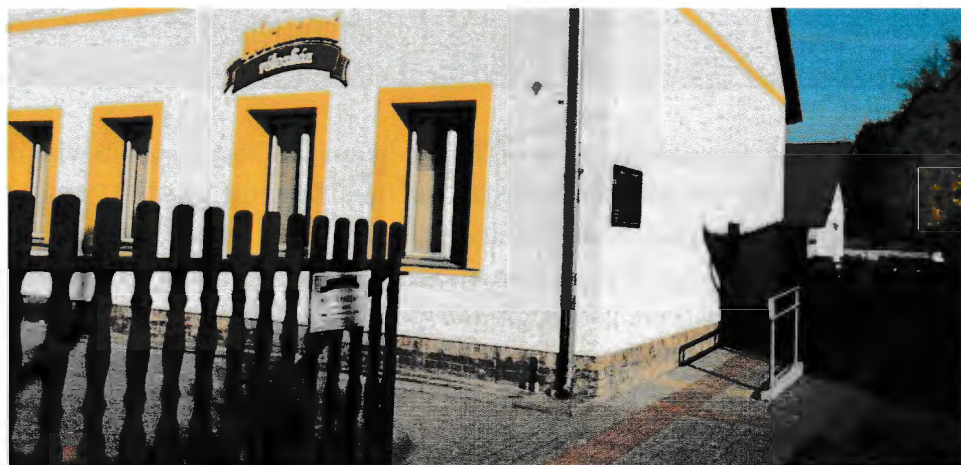
**General findings around accessibility:** There is designated parking next to the building. At the front door, the level difference is bridged with a ramp that complies with regulations. There is also tactile paving leading from the parking lot to the entrance. Inside the building, the flooring is even and non-slip. The accessible bathroom meets the requirements: the toilet can be approached from the front and from the right. The washbasin can be tilted, but the handle obstructs the appropriate knee clearance.

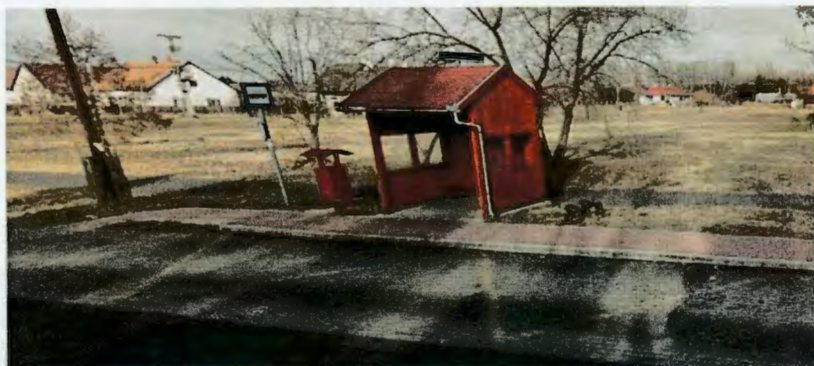
**General findings around accessibility:** There are a total of 11 bus stops in the town and most of them are renovated. The main issue is, however, that the ramps lead to the road instead of the pavement in most cases. The bus stop closest to the entrance of the Ópusztaszer Heritage Park is not renovated.

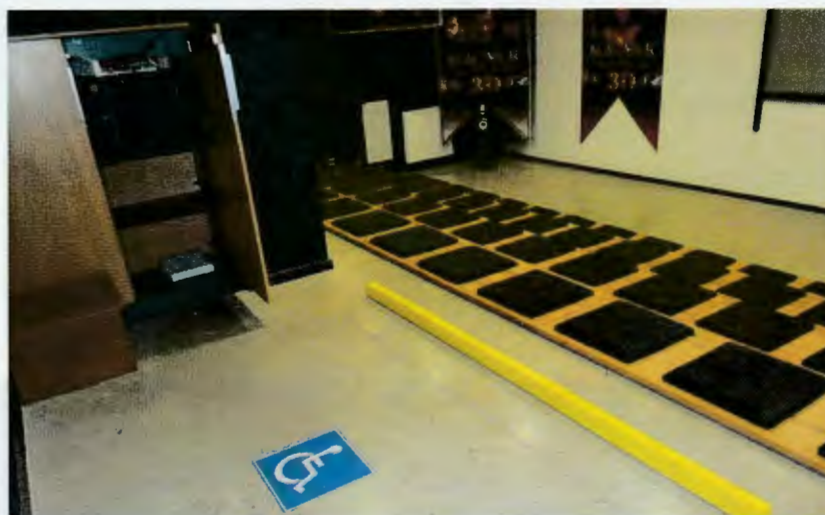
**General findings around accessibility:** The Visitor Centre has an induction loop installed. Tactile exhibitions are regularly organised. The accessible bathroom does not have handrails next to the toilet and there is not enough room to turn around in a wheelchair. The outdoor attractions are accessible on paved, smooth roads and small electric cars can be rented to get around easily on the premises. The 3D movie theatre has designated places for wheelchairs right next to the entrance, which does not affect the escape route. The accessible bathroom next to the Rotunda complies with the regulations.

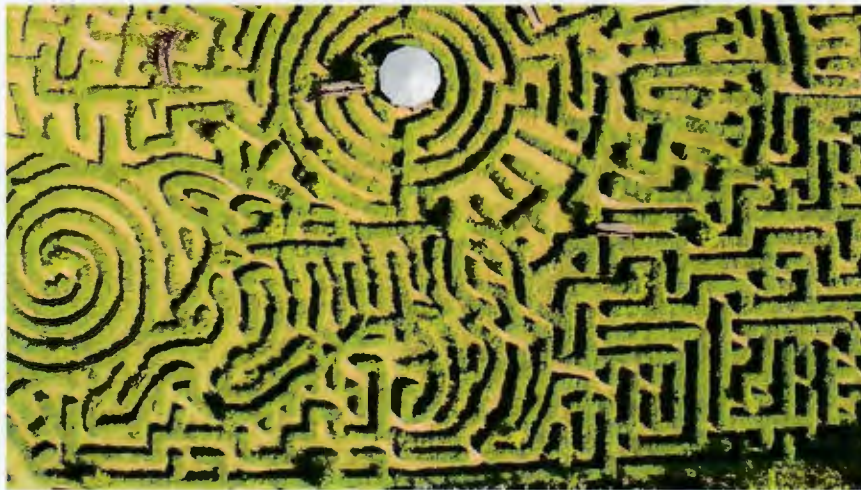
**General findings around accessibility:** This is a seasonal attraction, an outdoor labyrinth built from various bushes. There is a bus stop right at the entrance and there is also visitor parking, although there is no accessible parking for visitors with disabilities. According to the owners, the maze is accessible for people in a wheelchair as well. A new field visit is recommended when the maze opens for the season.

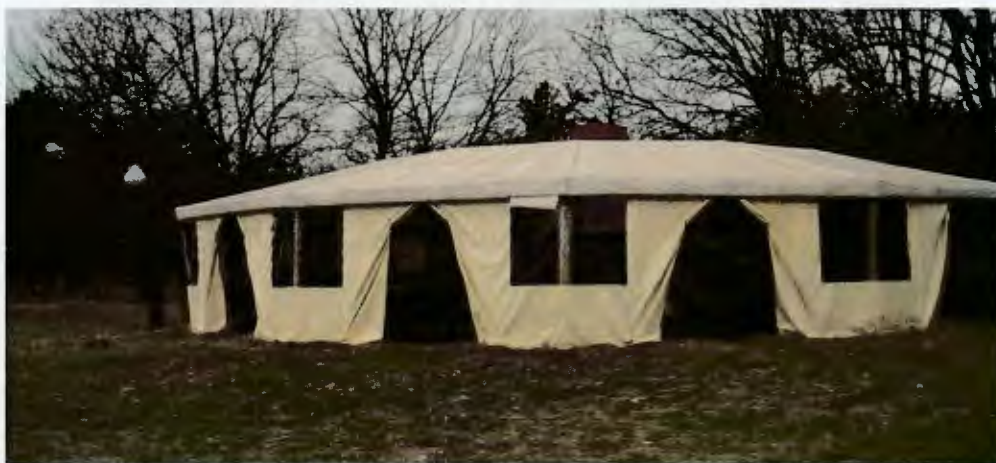
Name of Institution: **Herd of Akhal Teke Horses**

**General findings around accessibility:** The herd of horses is located outside of the village, approximately 2,5 kilometres away from the centre. It is only accessible by car, as a dirt road leads to the entrance, which branches off, from the main road. This means that the conditions are greatly influenced by the weather and how wet the soil is. There are no accessible bathrooms on site. In the past, therapeutic horse-riding sessions were held for people with intellectual disabilities and people with physical disabilities, and the owners are open to organise similar sessions in the future.
