# Accessibility Guidelines for tourism destination

**QUAD: Accessible Eco-Tourism Social Entrepreneurship  
(HUSRB/1602/42/0045)**

Increased understanding and knowledge on accessibility in tourism  
**Act.1.3 Accessibility Guidelines for tourism destination**

*Created by Motiváló Limited Partnership (42 Tegzes street, Budapest)  
Lead Expert: Péterné Zalabai, rehabilitation environmental expert  
Commissioned by the Association of Persons with Disabilities, Csongrád county*

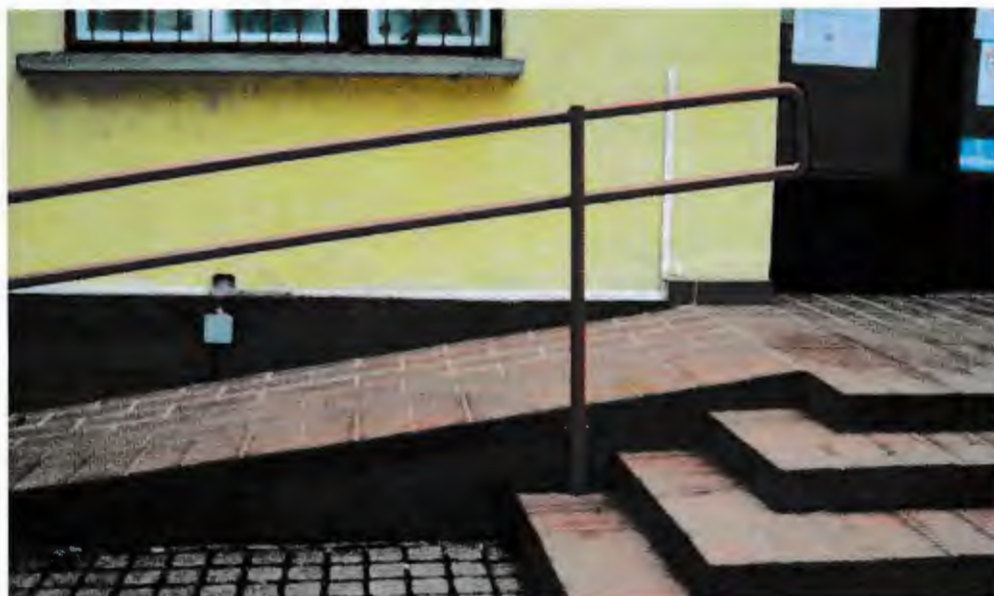
**General findings around accessibility:** The Mayor's Office is located in the centre of the village. A pavement in good condition leads to the building from one of the bus stops. There is no accessible parking in the vicinity of the building and the closest parking spaces have an uneven surface. At the front door, the level difference is bridged by a ramp that complies with regulations. The front door has a threshold that is approximately 2,5 centimetres high. There is even and non-slip flooring inside the building. There are no accessible bathrooms in the building.

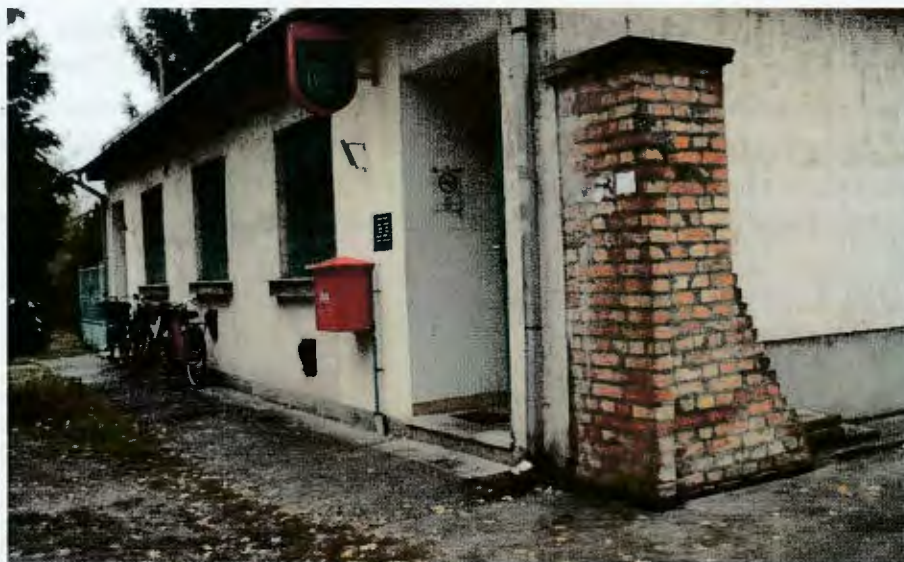
**General findings around accessibility:** The entrance to the post office is not accessible; there is a tall step at the front door. The interior is spacious and there is even and non-slip flooring. The height of the client window is not appropriate and it does not have appropriate knee clearance.

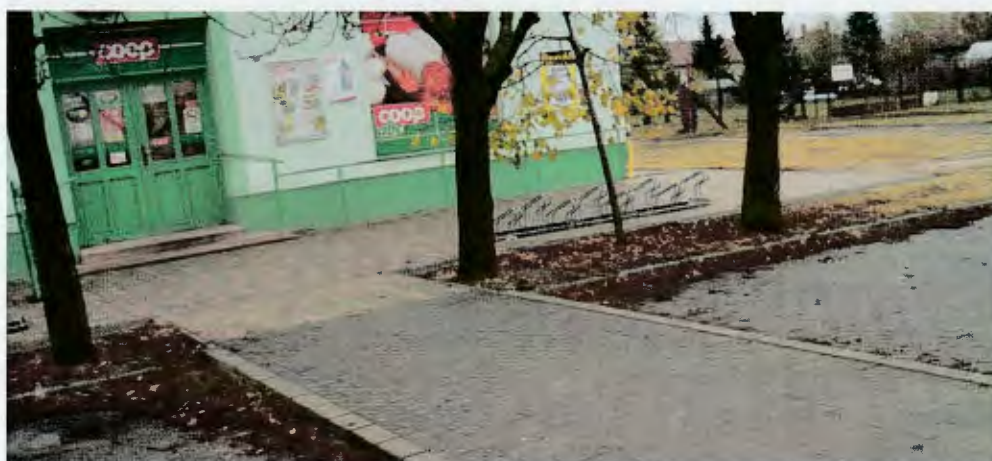
**General findings around accessibility:** There are parking spaces in front of the building, but there is no accessible parking for customers with disabilities. The entrance to the grocery store is not accessible, there is a tall step at the front door.

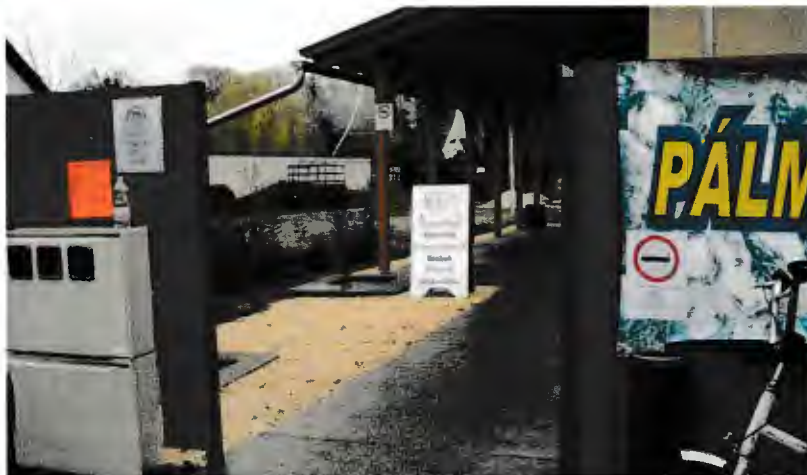
**General findings around accessibility:** There are parking spaces in front of the building, but there is no accessible parking for customers with disabilities. The entrance to the grocery store is not accessible; there are a couple of stairs before the front door. However, a bell can be used to call for the cashier who can bring the selected items outside.

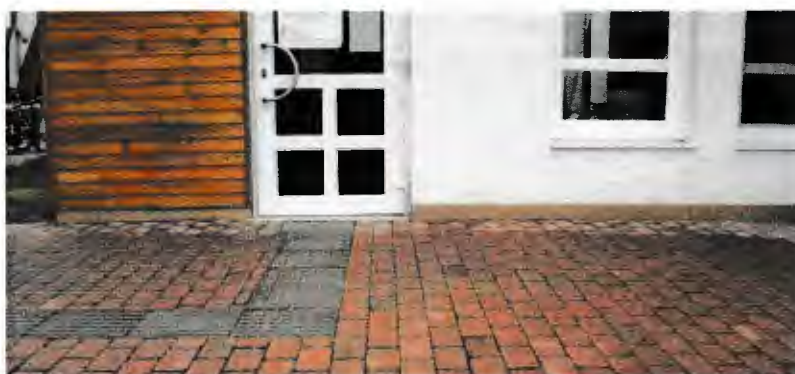
**General findings around accessibility:** The building was renovated recently. The front door is accessible without a level difference and tactile paving leads to it. The different doctor's offices can be accessed directly from the outside, or alternatively from the waiting room. Inside the building, tactile paving helps patients with visual disabilities. There are information boards on each door to help with orientation. In the accessible bathroom, the toilet is placed in the corner, so it can be approached from the front and from the left.

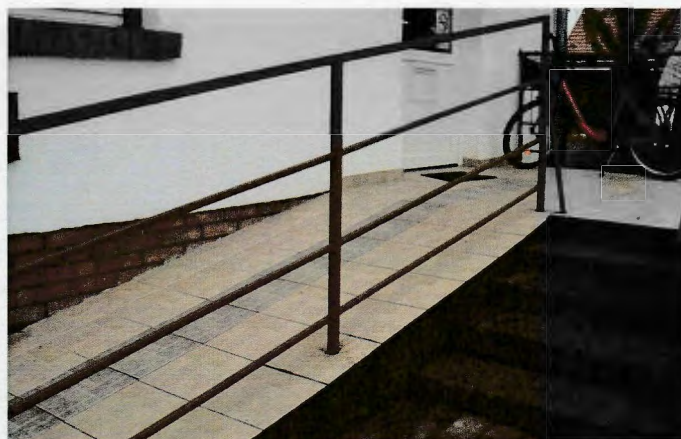
**General findings around accessibility:** The renovated pharmacy was recently opened to the public. At the front door, the level difference is bridged by a ramp that complies with regulations. One line of the tiles on the ramp is laid in a different colour, but its surface is the same as the other tiles, and its colour is not contrasting enough to function as tactile paving. The interior is spacious and there is even and non-slip flooring inside the building. The height of the client window is appropriate.

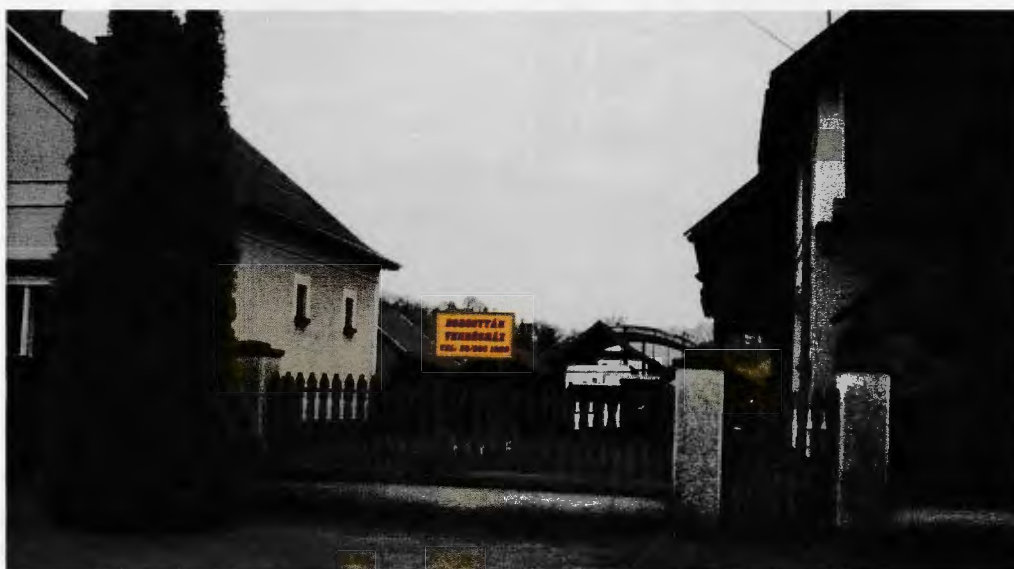
**General findings around accessibility:** The owners operate two guesthouses in the village, but none of the buildings are accessible. Parking is available right next to the front door. There are no accessible bathrooms in the buildings.

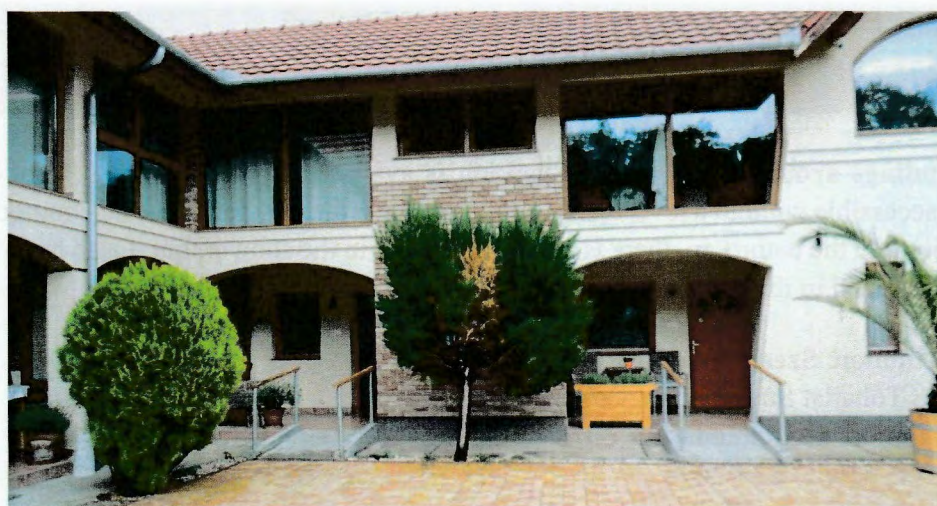
**General findings around accessibility:** Parking is available in the courtyard of the accommodation. For the rooms on the ground, the level difference is bridged by a ramp that complies with regulations. The bathrooms are not accessible: there is not enough free space in front of the toilet, there are no handrails, and the shower has thresholds. The doors within the building also have a low threshold everywhere.

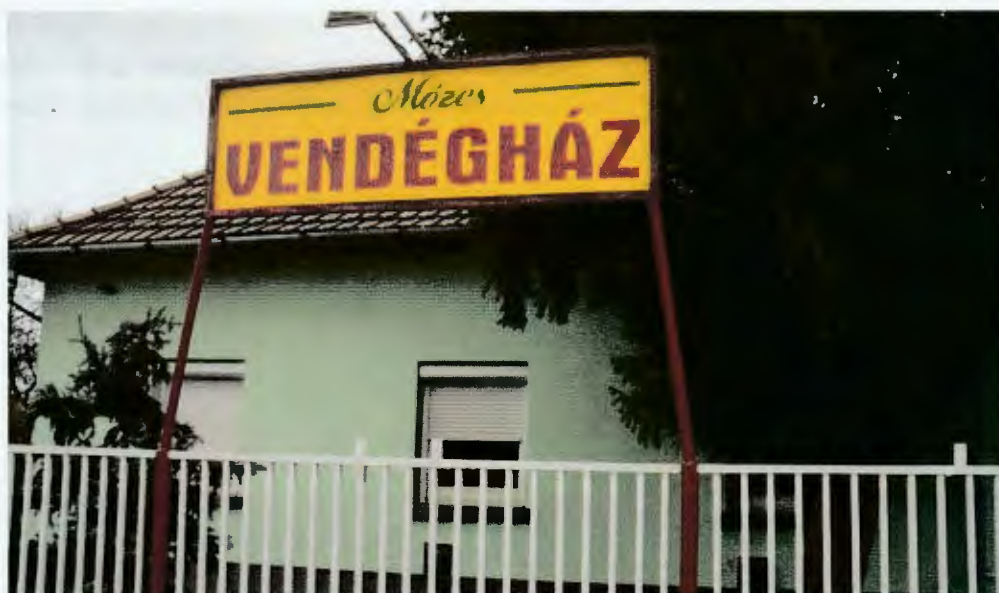
**General findings around accessibility:** Parking is available right next to the front door. The entrance is accessible without a level difference. The rooms are spacious. The accommodation also has a salt room. In the bathroom, there is a fold-down seat in the shower, but it also has a threshold. The toilet is located in the corner and does not have any handrails.

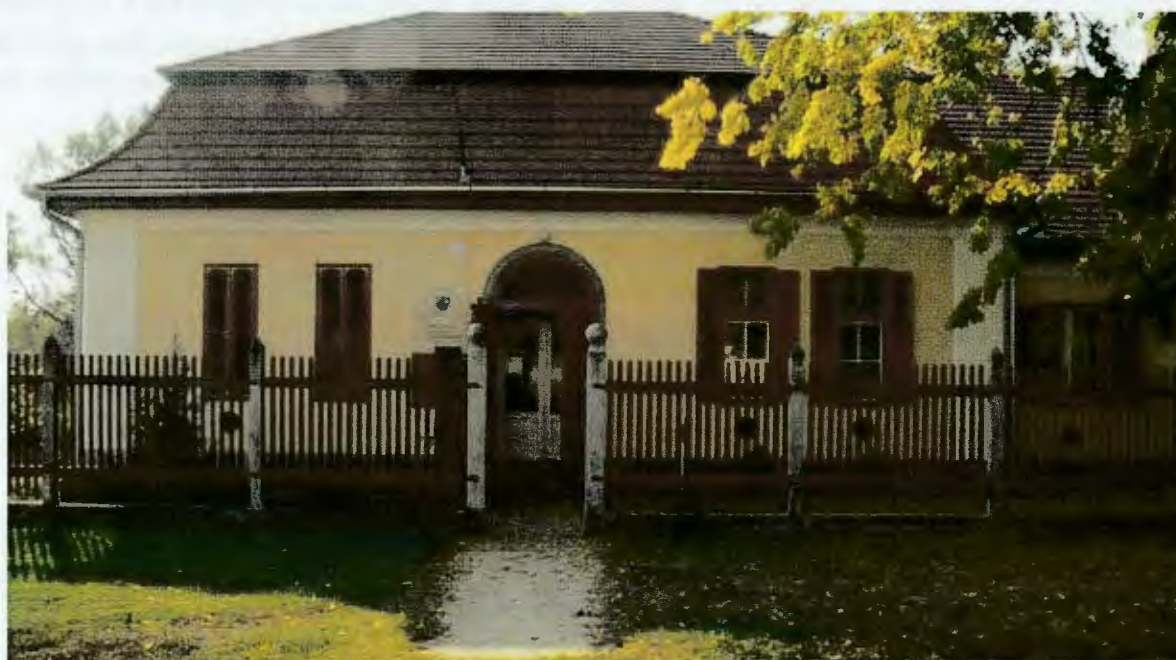
Name of Institution: **Szeri Catholic Youth Hostel**

**General findings around accessibility:** The building was last renovated in 2002 when the principles of accessibility were not taken into account. The building has no accessible parking available. The flooring on the terrace is slippery. The interior of the building is spacious but the doors have a threshold everywhere. There are no accessible bathrooms.

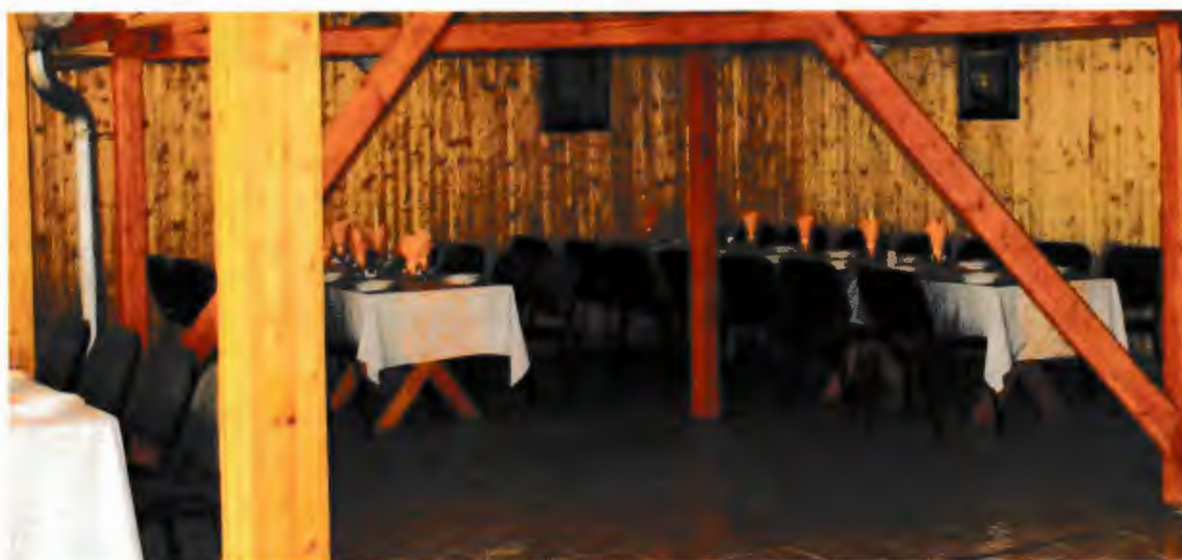
Name of Institution: **Kemencés Restaurant**  
Address: 23 Komócsin Zoltán Street, Ópusztaszer  
Type of institution: restaurant  
Phone number: +36/30-627-4428  
Website: [www.kemencescsarda.hu](http://www.kemencescsarda.hu)

**General findings around accessibility:** One of the largest restaurants in town that can accommodate up to 320 people at the same time. One of the renovated bus stops is close to the restaurant. Parking is available right next to the entrance but there is no accessible parking for guests with disabilities. The entrance is accessible without a level difference and the reception also complies with regulations. Some of the tables have appropriate knee clearance. In the summer season, the terrace is also fully accessible. There are currently no accessible bathrooms; the owners plan to establish one in the future.

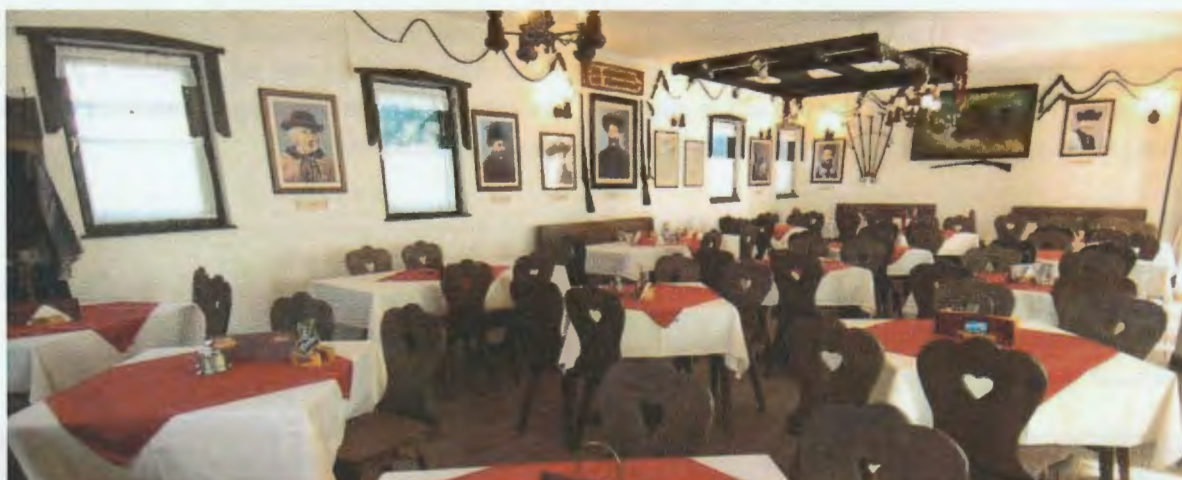
Name of Institution: **Szeri Restaurant**  
Address: 111 Pusztaszeri major, Ópusztaszer  
Type of institution: restaurant  
Phone number: +36/70-413-4203  
Website: [www.szericsarda.hu](http://www.szericsarda.hu)

**General findings around accessibility:** Stairs lead to the entrance of the restaurant. The owners of the restaurants can place a temporary ramp on them, but this ramp does not comply with the regulations. Even though most tables have appropriate knee clearance, there is not enough free space between them for people in a wheelchair. In the summer season the terrace is open, which is accessible without a level difference. There are currently no accessible bathrooms.

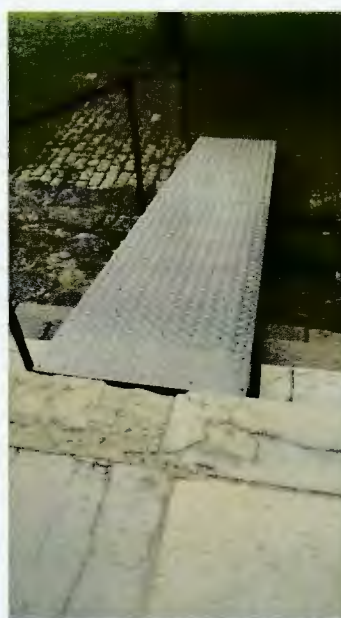
**General findings around accessibility:** The main entrance of the church is not accessible. However, there is a ramp at the side entrance in the garden of the church, but the garden is usually closed to the public. All attractions within the building can be accessed without a level difference. There are no accessible bathrooms.

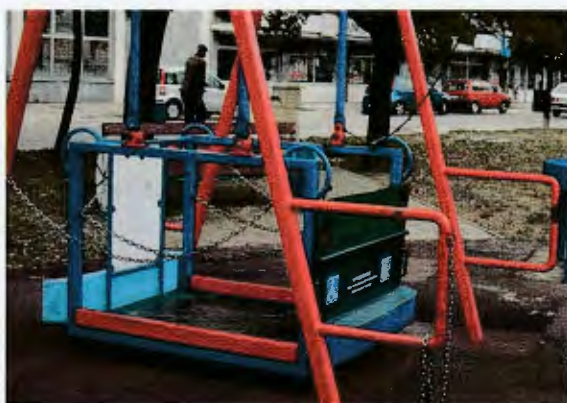
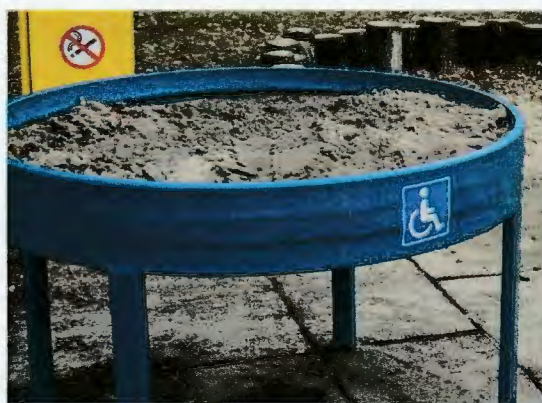
Name of Institution: **Accessible Playground**

**General findings around accessibility:** In the city centre, a wheelchair-accessible playground has been established, featuring several different types of games.

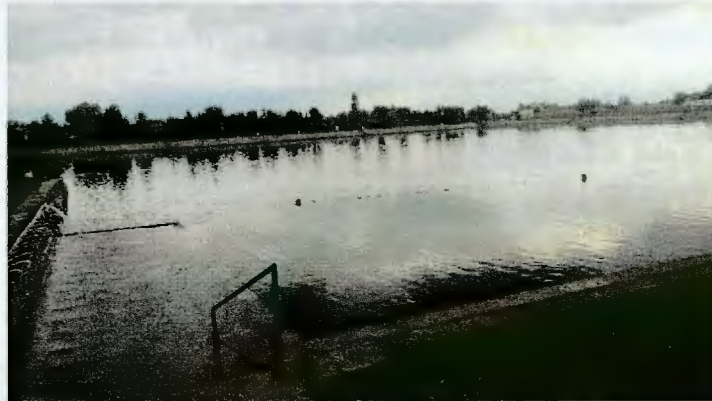
Name of Institution: **Public Beach**  
Address: Vršac, Vršačko jezero  
Type of institution: tourist attraction  
Phone number: N/A  
Website: N/A

**General findings around accessibility:** The artificial lake is located at the edge of the city. One side of its shore is covered in concrete and the other half is covered in sand. There is a paved sidewalk that goes along the shore. The water is deep and suitable for bathing, it is quite popular in the summer season. However, there are no accessible ways to get into the water.

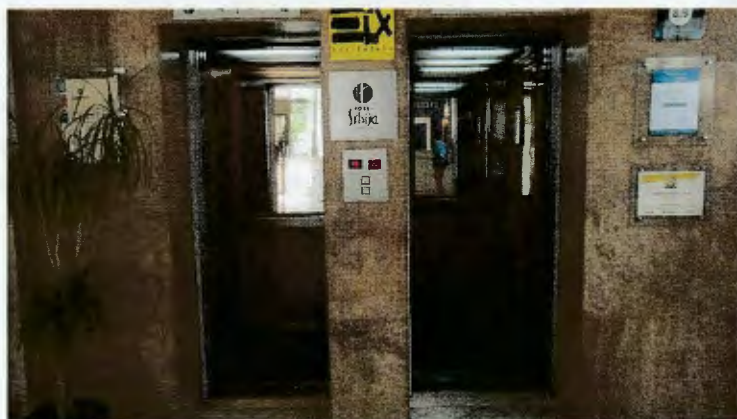
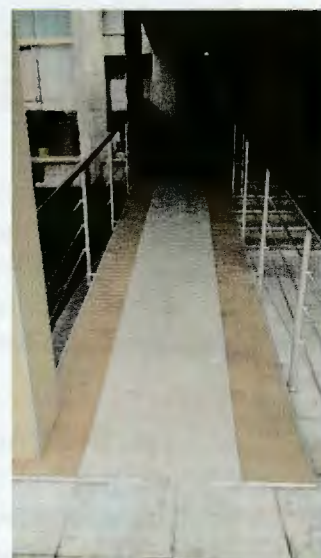
Name of Institution: **Hotel Srbija**  
Address: Vršac, Svetosavski trg 12  
Type of institution: accommodation  
Phone number: +381 13 834 170  
Website: <http://www.hotelsrbija.rs/>

**General findings around accessibility:** The accommodation can host 4 people with disabilities at the same time. There is no accessible parking. At the front door, the level difference is bridged by a ramp. Within the building, the reception, the restaurant and the conference room are all accessible without level difference. Movement between floors is made accessible by an elevator, which complies with regulations. The accessible rooms are located on the second and third floors. Their doors have appropriate dimensions. The height of the bed is appropriate for transferring from a wheelchair. In the accessible bathroom, the toilet is equipped with handrails. The washbasin cannot be tilted. The shower has no thresholds and the drain is in line with the floor.

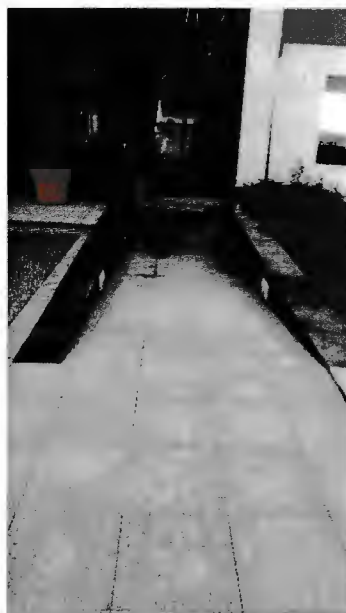
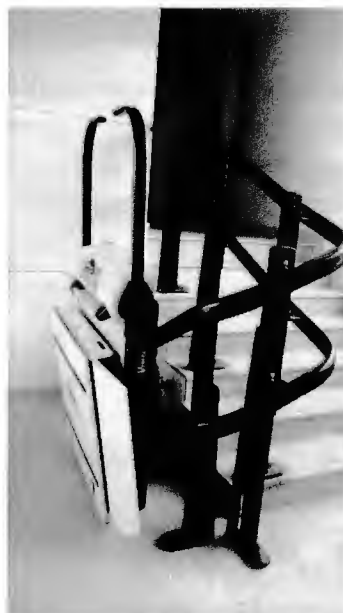
Name of Institution: **Hotel Villa Breg**

**General findings around accessibility:** The accommodation does not have accessible rooms. Parking is available next to the entrance; there is no accessible parking for guests with disabilities. At the entrance, the level difference is bridged by a ramp. The front door can be accessed by a stair lift. All of the bathrooms have a bathtub or a shower with high thresholds. The toilet sits too low and it is not equipped with handrails.

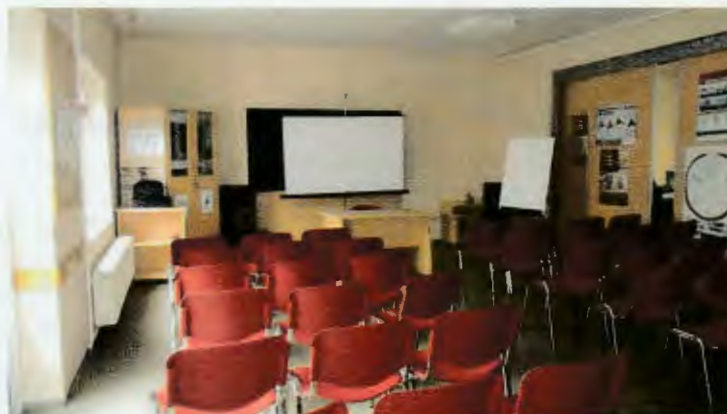
Name of Institution: **Red Cross Guesthouse**

**General findings around accessibility:** This accommodation is operated by the Red Cross. It is mostly used for the rehabilitation of disadvantaged young people these days. There is no accessible parking for visitors with disabilities. At the front door, the level difference is bridged by a ramp, which does not meet the relevant requirements. On the ground floor of the building, the restaurant and the conference rooms are all accessible without level difference. There are currently no accessible rooms and bathrooms in the building, and the second floor can only be reached via stairs.

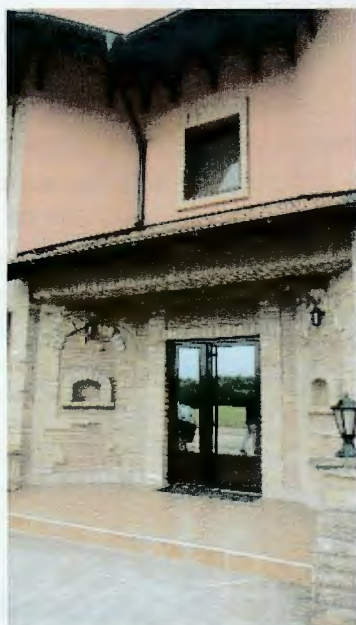
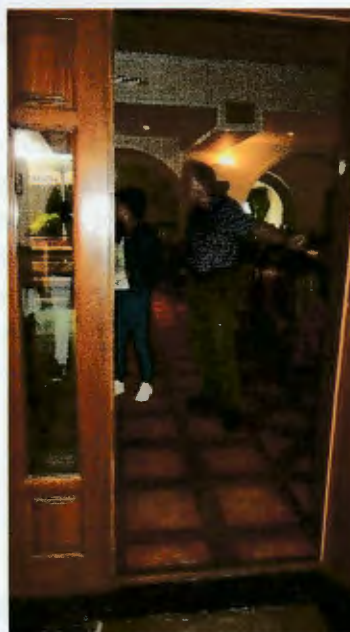
**General findings around accessibility:** The building is currently not accessible. There is a high step in front of the entrance. Inside the building, the restaurant is accessible without level difference. The second floor can only be reached via stairs. The rooms on the ground floor are not accessible without level difference.

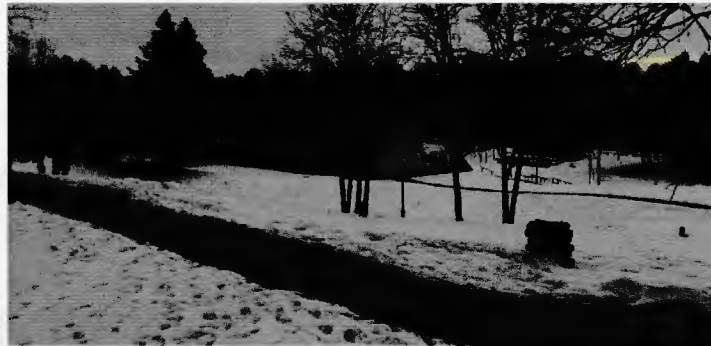
Name of Institution: **Čardak Tourist Centre**

**General findings around accessibility:** The building entrance is currently not accessible. Inside the building, the dining room is accessible without level difference. There are no accessible bathrooms. In the garden, there is a network of paved paths and the staircases can be bypassed everywhere. Several walking and cycling routes start next to the complex. The cycling routes are typically forest roads which are wide and do not provide a difficult terrain. There are three lookout towers in the area, but none of them are accessible currently.

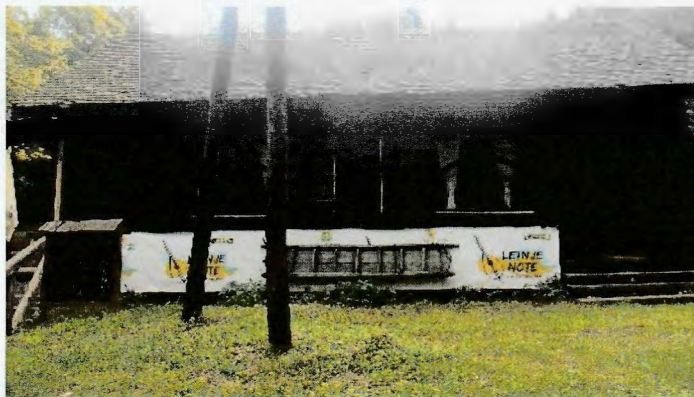
Name of Institution: **Caffe Brnavara**

**General findings around accessibility:** The parking lot is located near the entrance. The restaurant itself lies on a grassy, uneven terrain, but it is possible to park right next to the building entrance to avoid this area. The free space on the terrace is sufficient for wheelchair access. There are no accessible bathrooms.

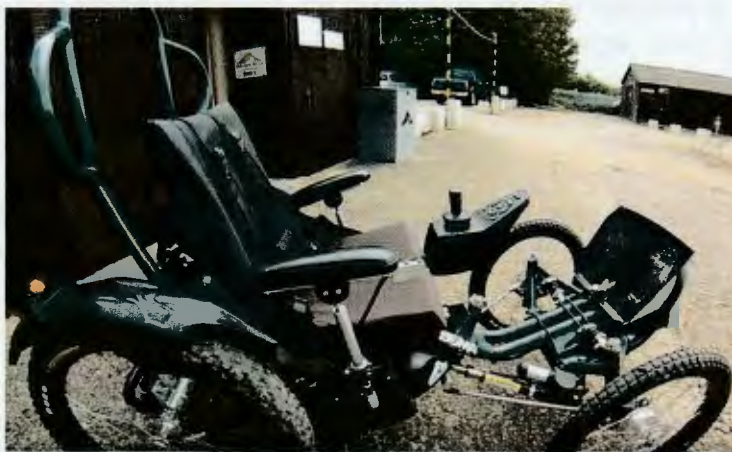
*Boma 7, the all-terrain wheelchair*

Furthermore, they could purchase of a number of tools that provide access to outdoor leisure activities such as a wheelchair-accessible fishing boat, barrier-free equipment for an accessible camping pod and an all-terrain wheelchair. In addition to all these activities, they recognised the importance of media coverage in order to reach more and more people with this initiative. This is achieved through increasing presence both traditional and social media.

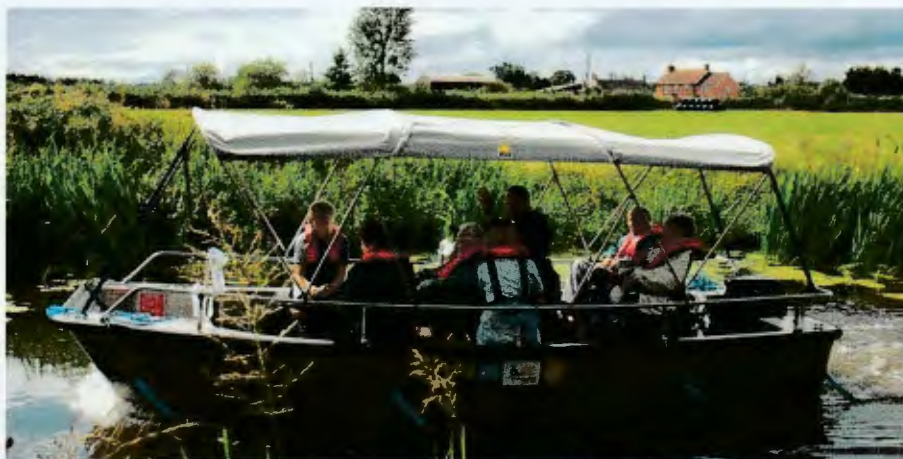
*Wheelchair-accessible fishing boat*

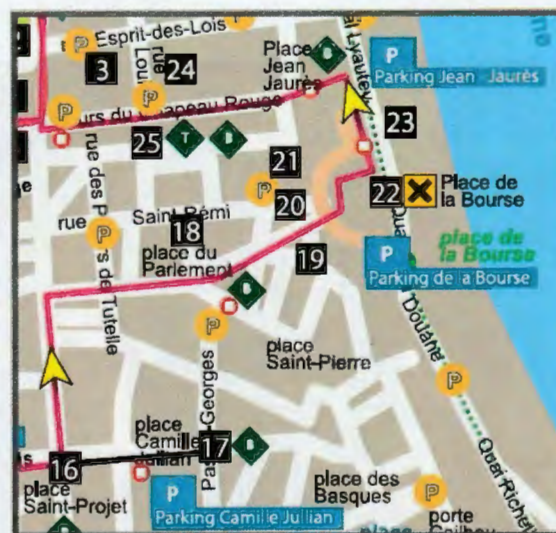
Example of the accessible itinerary in the centre of Bordeaux  
Source:

Based on this information, there are also itineraries for three different routes that are accessible to help those who would like to explore the city centre. In addition to a brief description on all the attractions, it also provides useful information such as the location of the closest accessible parking space, sculptures at wheelchair level, or the best location to cross the tram rails. Currently all the information is only available in French – a possible next step would be to translate this information into English so that the number of potential visitors can grow even further.

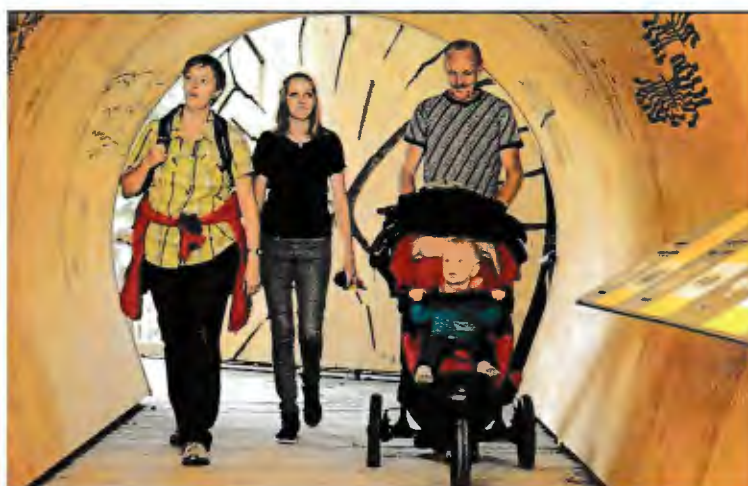
Entrance to the Wilder Weg educational trail  
Source: <https://www.eifel.info/en/a-wilder-weg>

Another great initiative is the accessible educational trail, which runs for 6 kilometres in the middle of the national park. Tactile guides are also installed, and guided tours in sign language can also be requested. It is easy to get to the trail itself, as there is accessible parking and bus connections right next to its starting point. Many of the surrounding hotels also offer accessible rooms, which makes it easy to plan a longer stay in this region.
